Sand Bar and Terrace Erosion Between 1964 and 1996 at the Tin Shed and Camp Creek  
Cultural Resource Sites on the Snake River in Hells Canyon

FINAL REPORT

August 20, 1999

Paul E. Grams and John C. Schmidt  
Department of Geography and Earth Resources  
Utah State University  
Logan, Utah 84322-5240

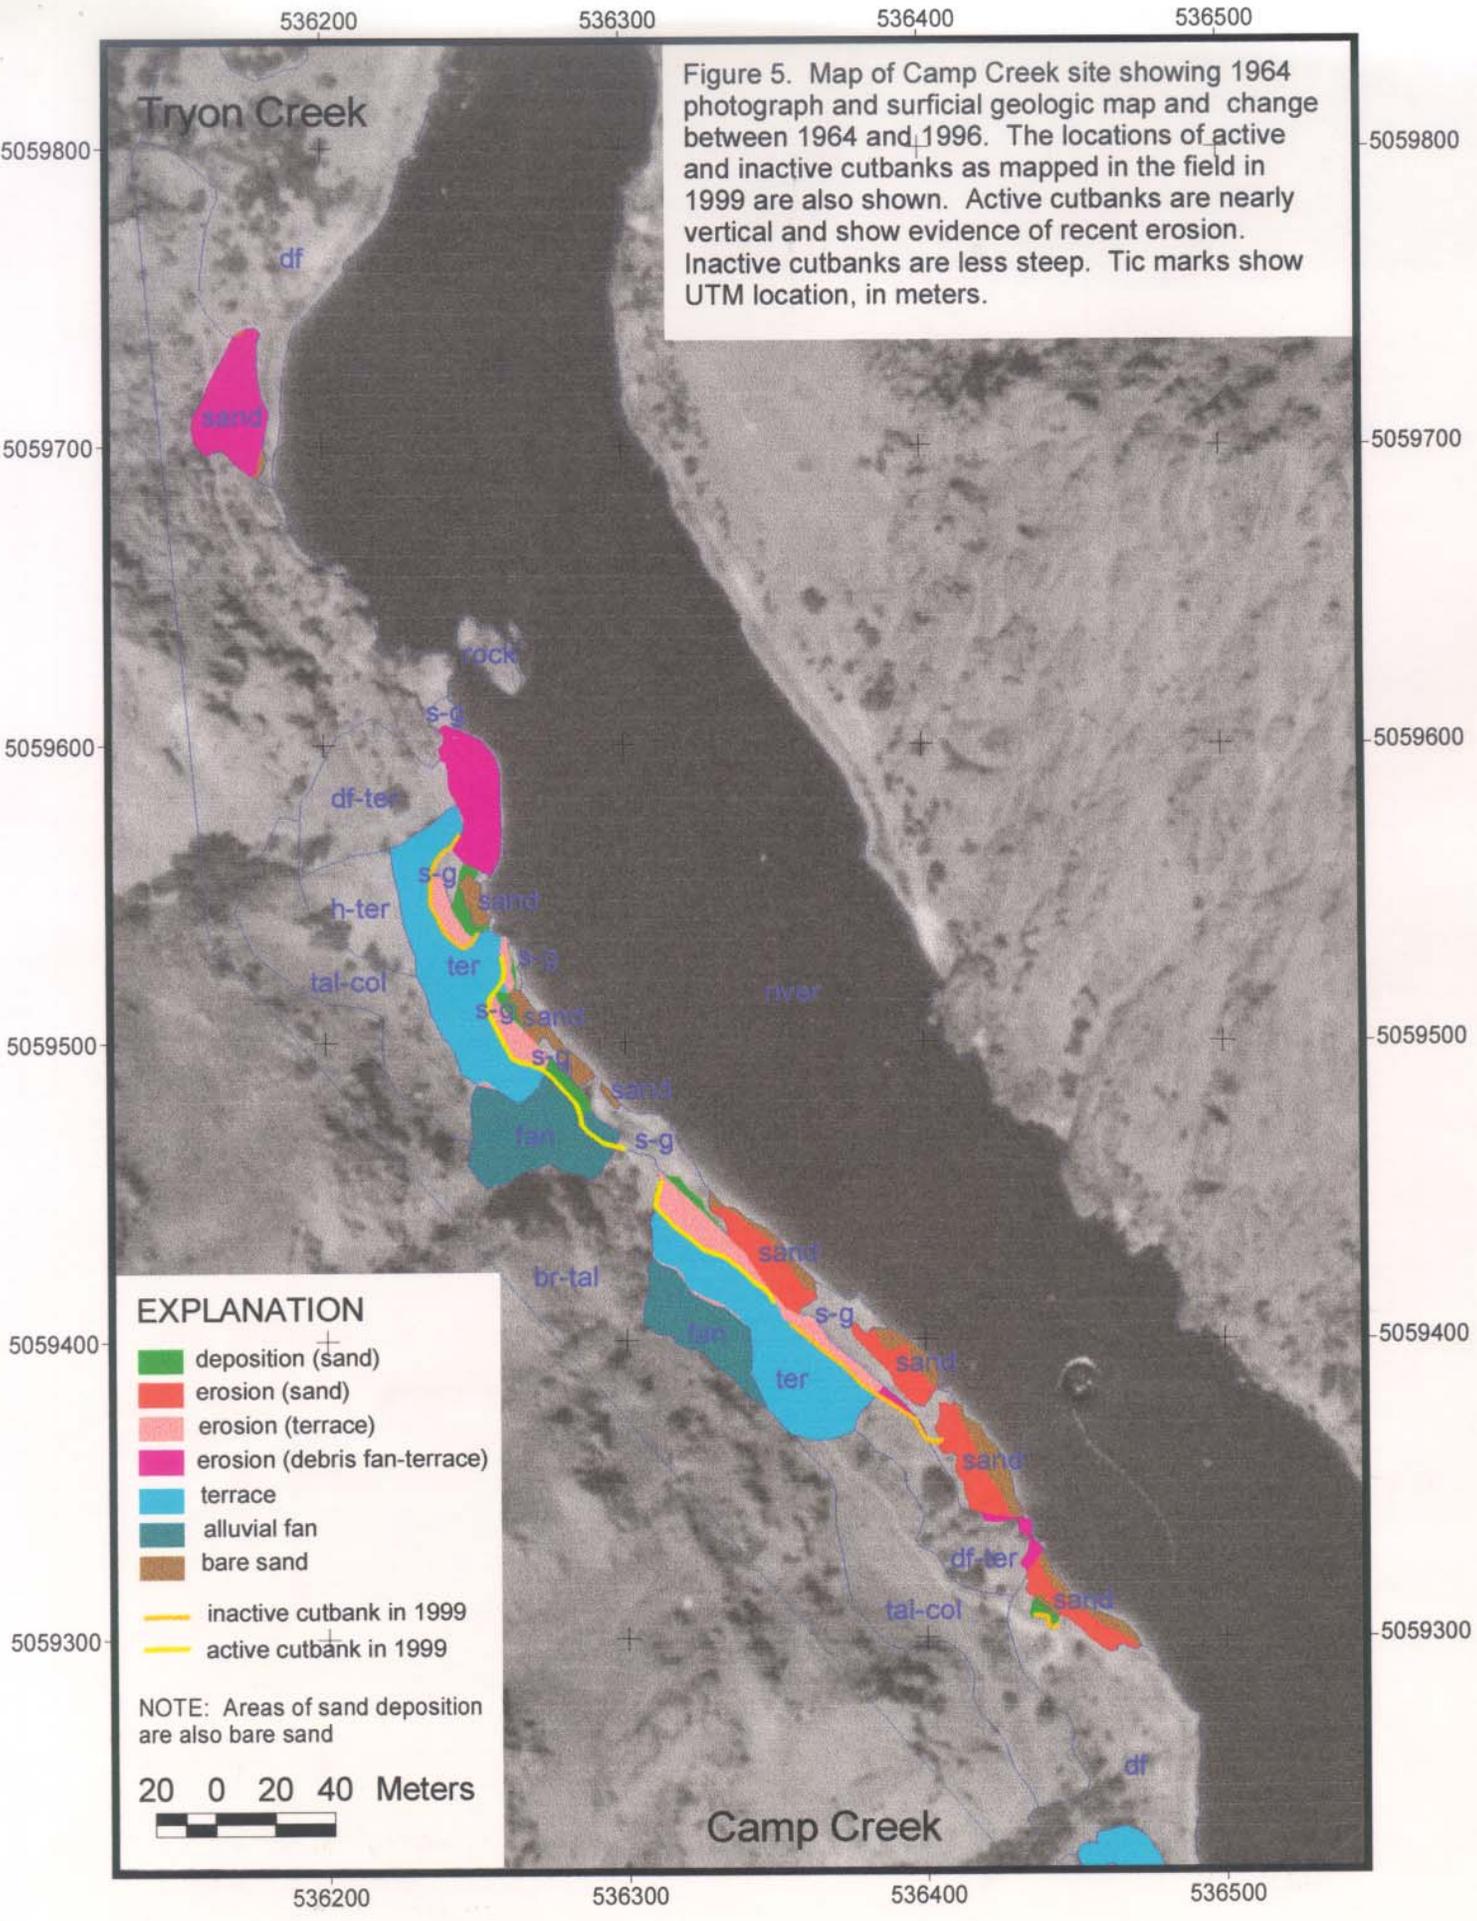
The net change at the Camp Creek site between 1964 and 1996 has been erosion of alluvial terrace deposits, debris fan-terrace deposits, and bare sand bars (Figure 5). Most of the areas where erosion of sand bars occurred are now armored by coarse-grained deposits of gravel or talus, that presumably have been exposed beneath the sand (areas that are mapped red in Figure 5). Net deposition of sand has occurred at a few locations adjacent to eroding terrace deposits, but these areas are small (areas that are mapped bright green in Figure 5). Erosion of the alluvial terraces has occurred by retreat of steep cutbanks (Figure 6). Approximately 50% of the length of these cutbanks show evidence of recent erosion in 1999 (Figure 5), the remainder are less steep and do not appear to be actively eroding. The debris fan-terrace deposits consist of coarse, angular tributary fan deposits mantled by a thin veneer of Snake River sand that is typically between 10 and 20 cm thick. Where erosion of these deposits has occurred since 1964, the veneer of sand has been eroded and only the armored debris fan is now exposed (Figure 5). These features do not have active cutbanks and continued erosion is probably not occurring.

Erosion of the terraces occurred along the edges of nearly all the terrace deposits in the reach. These deposits are concentrated in the center of the study reach (Figure 5). Sand bar erosion has been greatest at the upstream end of the reach where there has been very little compensating deposition (Figure 5). Most of the areas where sand bars occurred in 1996 were adjacent to eroding terraces. Thus, these bars may be composed

Figure 5. Map of Camp Creek site showing 1964 photograph and surficial geologic map and change between 1964 and 1996. The locations of active and inactive cutbanks as mapped in the field in 1999 are also shown. Active cutbanks are nearly vertical and show evidence of recent erosion. Inactive cutbanks are less steep. Tic marks show UTM location, in meters.

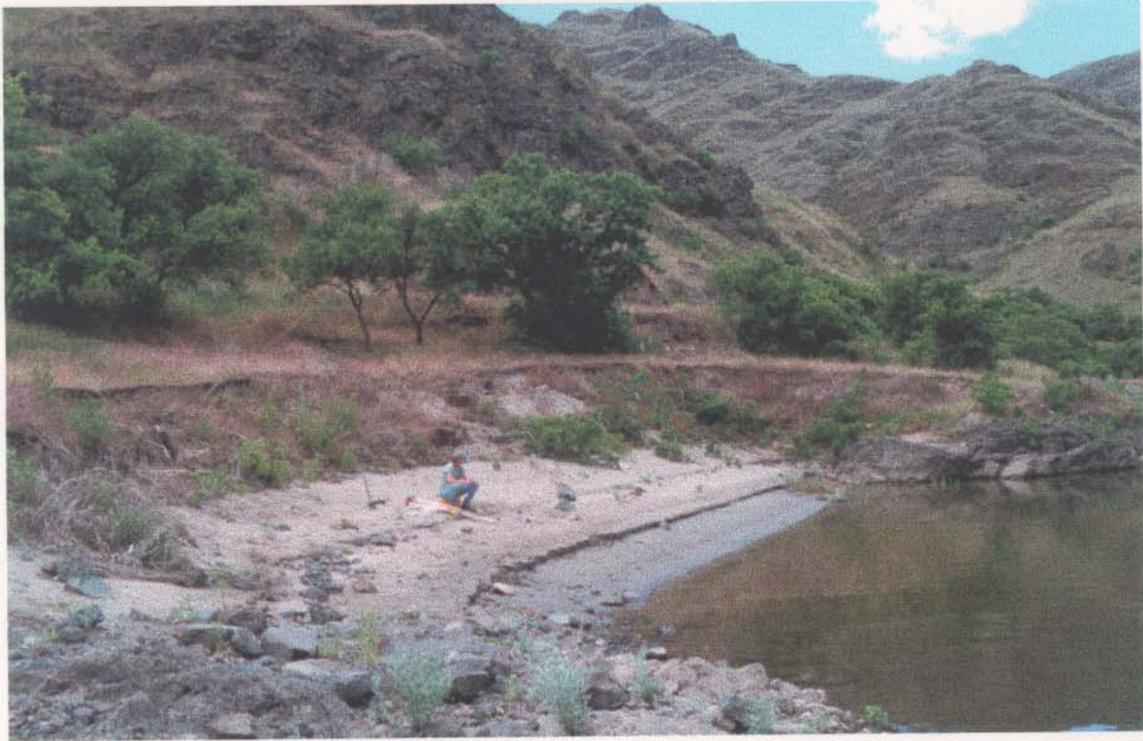
Figure 6. Photograph of eroding cutbank on the edge of the terrace at Camp Creek.

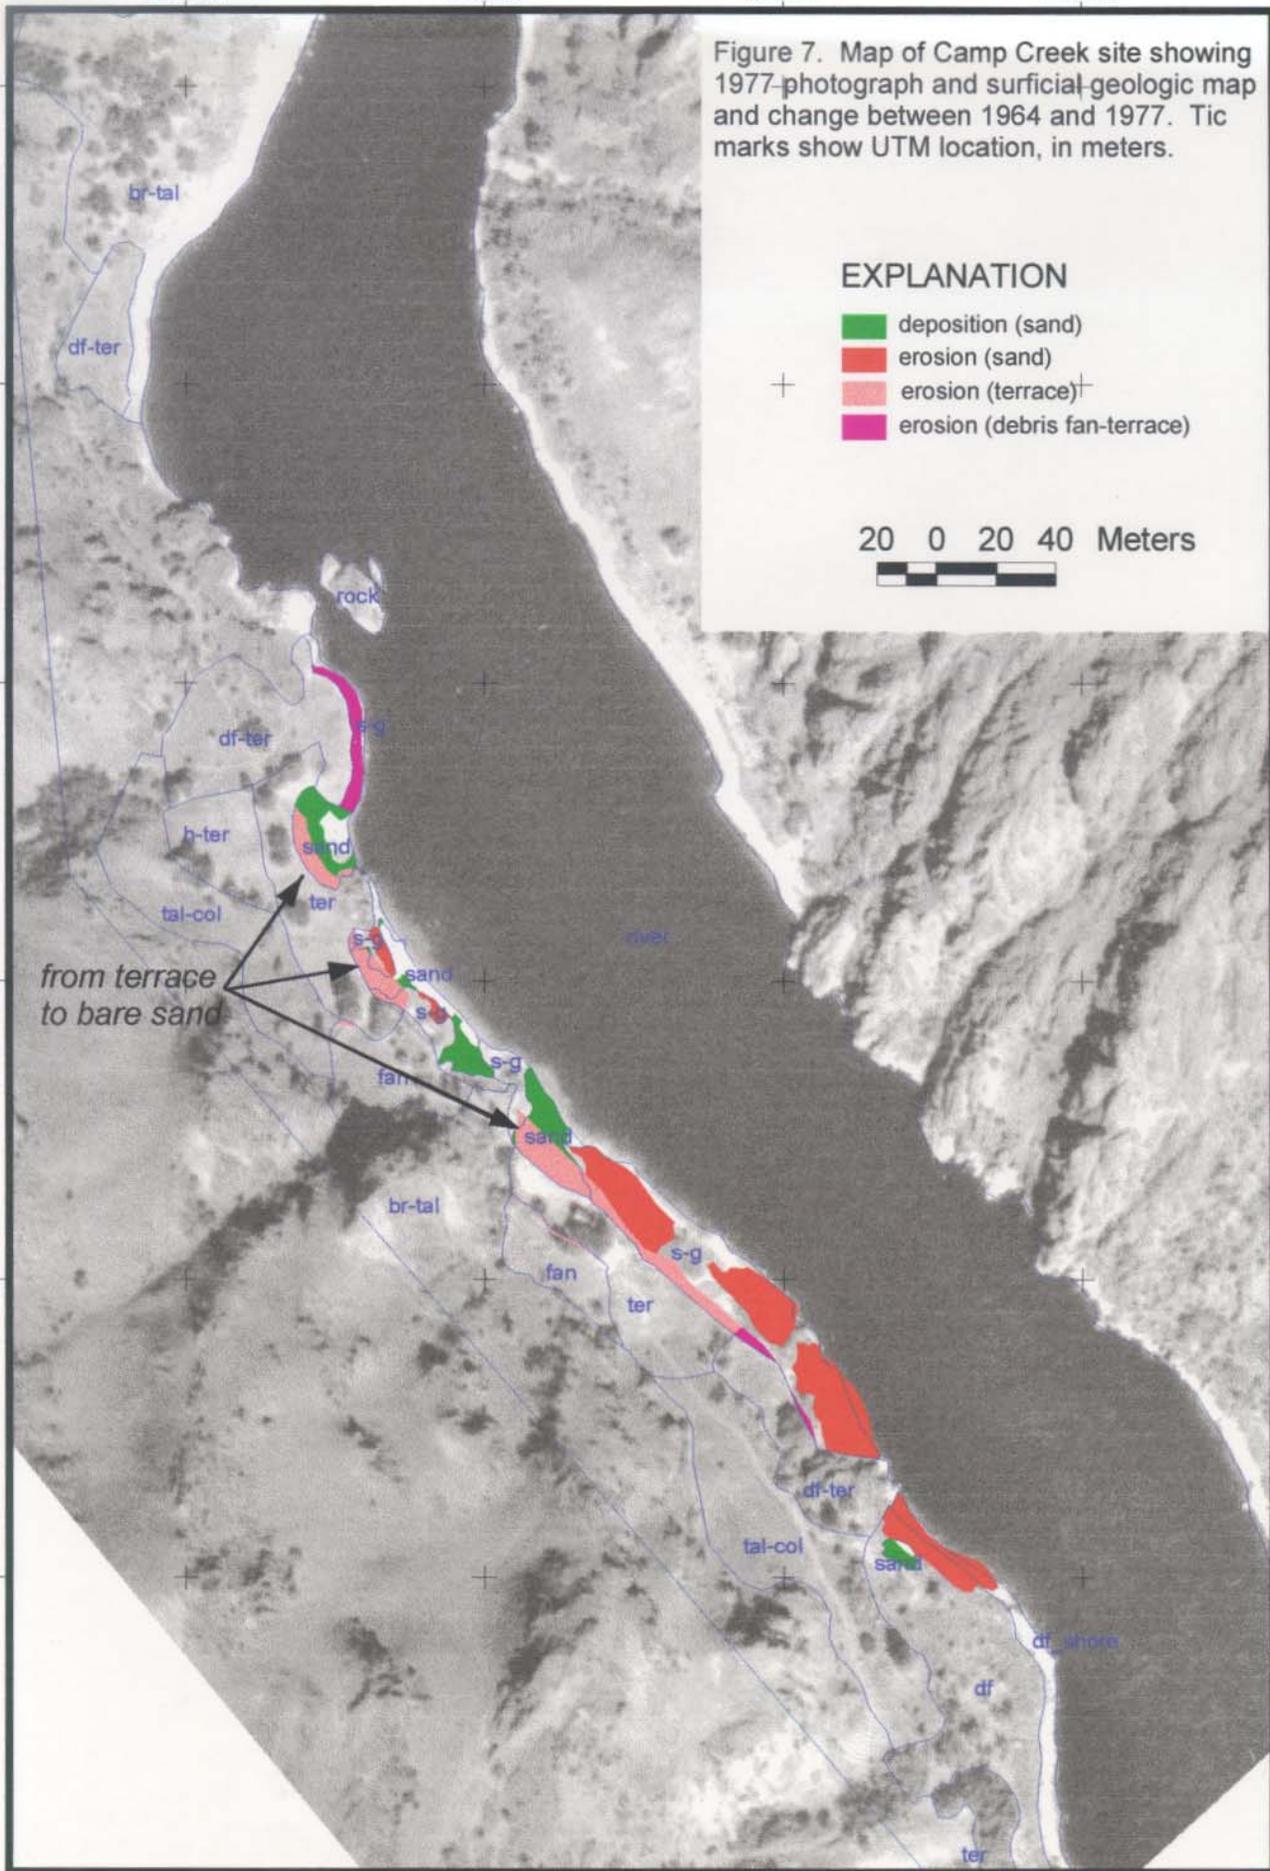
Comparison of changes between each of the years of photography provides an opportunity to assess the rate and style of erosion at Camp Creek. In 1964, the Camp Creek site contained many large sand deposits at the upstream end of the reach, just downstream from the Camp Creek debris fan (Figure 5). These were primarily eddy deposits, located in the lee of the Camp Creek debris fan and bedrock outcrops downstream from the fan. By 1977, much of this sand had been eroded and these deposits were armored by gravel (Figure 7). Erosion of the terrace occurred at several

locations. Much of this erosion occurred adjacent to eroding sand bars (areas where terrace erosion is next to sand erosion in Figure 7). In some locations, the eroded terrace deposits became bare sand deposits, increasing the area of bare sand (Figure 7). The total area of erosion of sand bars exceeded the area of deposition (Table 3).

These data demonstrate that most of the erosion of the alluvial terrace deposits occurred between 1964 and 1977 (Figure 7). In only a few locations did erosion occur both in the 1964 to 1977 period and in the 1982 to 1996 period. The persistence of erosion in recent years is indicated by the widespread active cutbanks, but the present rates of cutbank retreat are unknown (Figure 5). The majority of the erosion of bare sand bars that we measured occurred in the same period as the period of terrace erosion (1964 to 1977), although a large area was also eroded between 1982 and 1996 (Table 3).

Figure 7. Map of Camp Creek site showing 1977 photograph and surficial-geologic map and change between 1964 and 1977. Tic marks show UTM location, in meters.

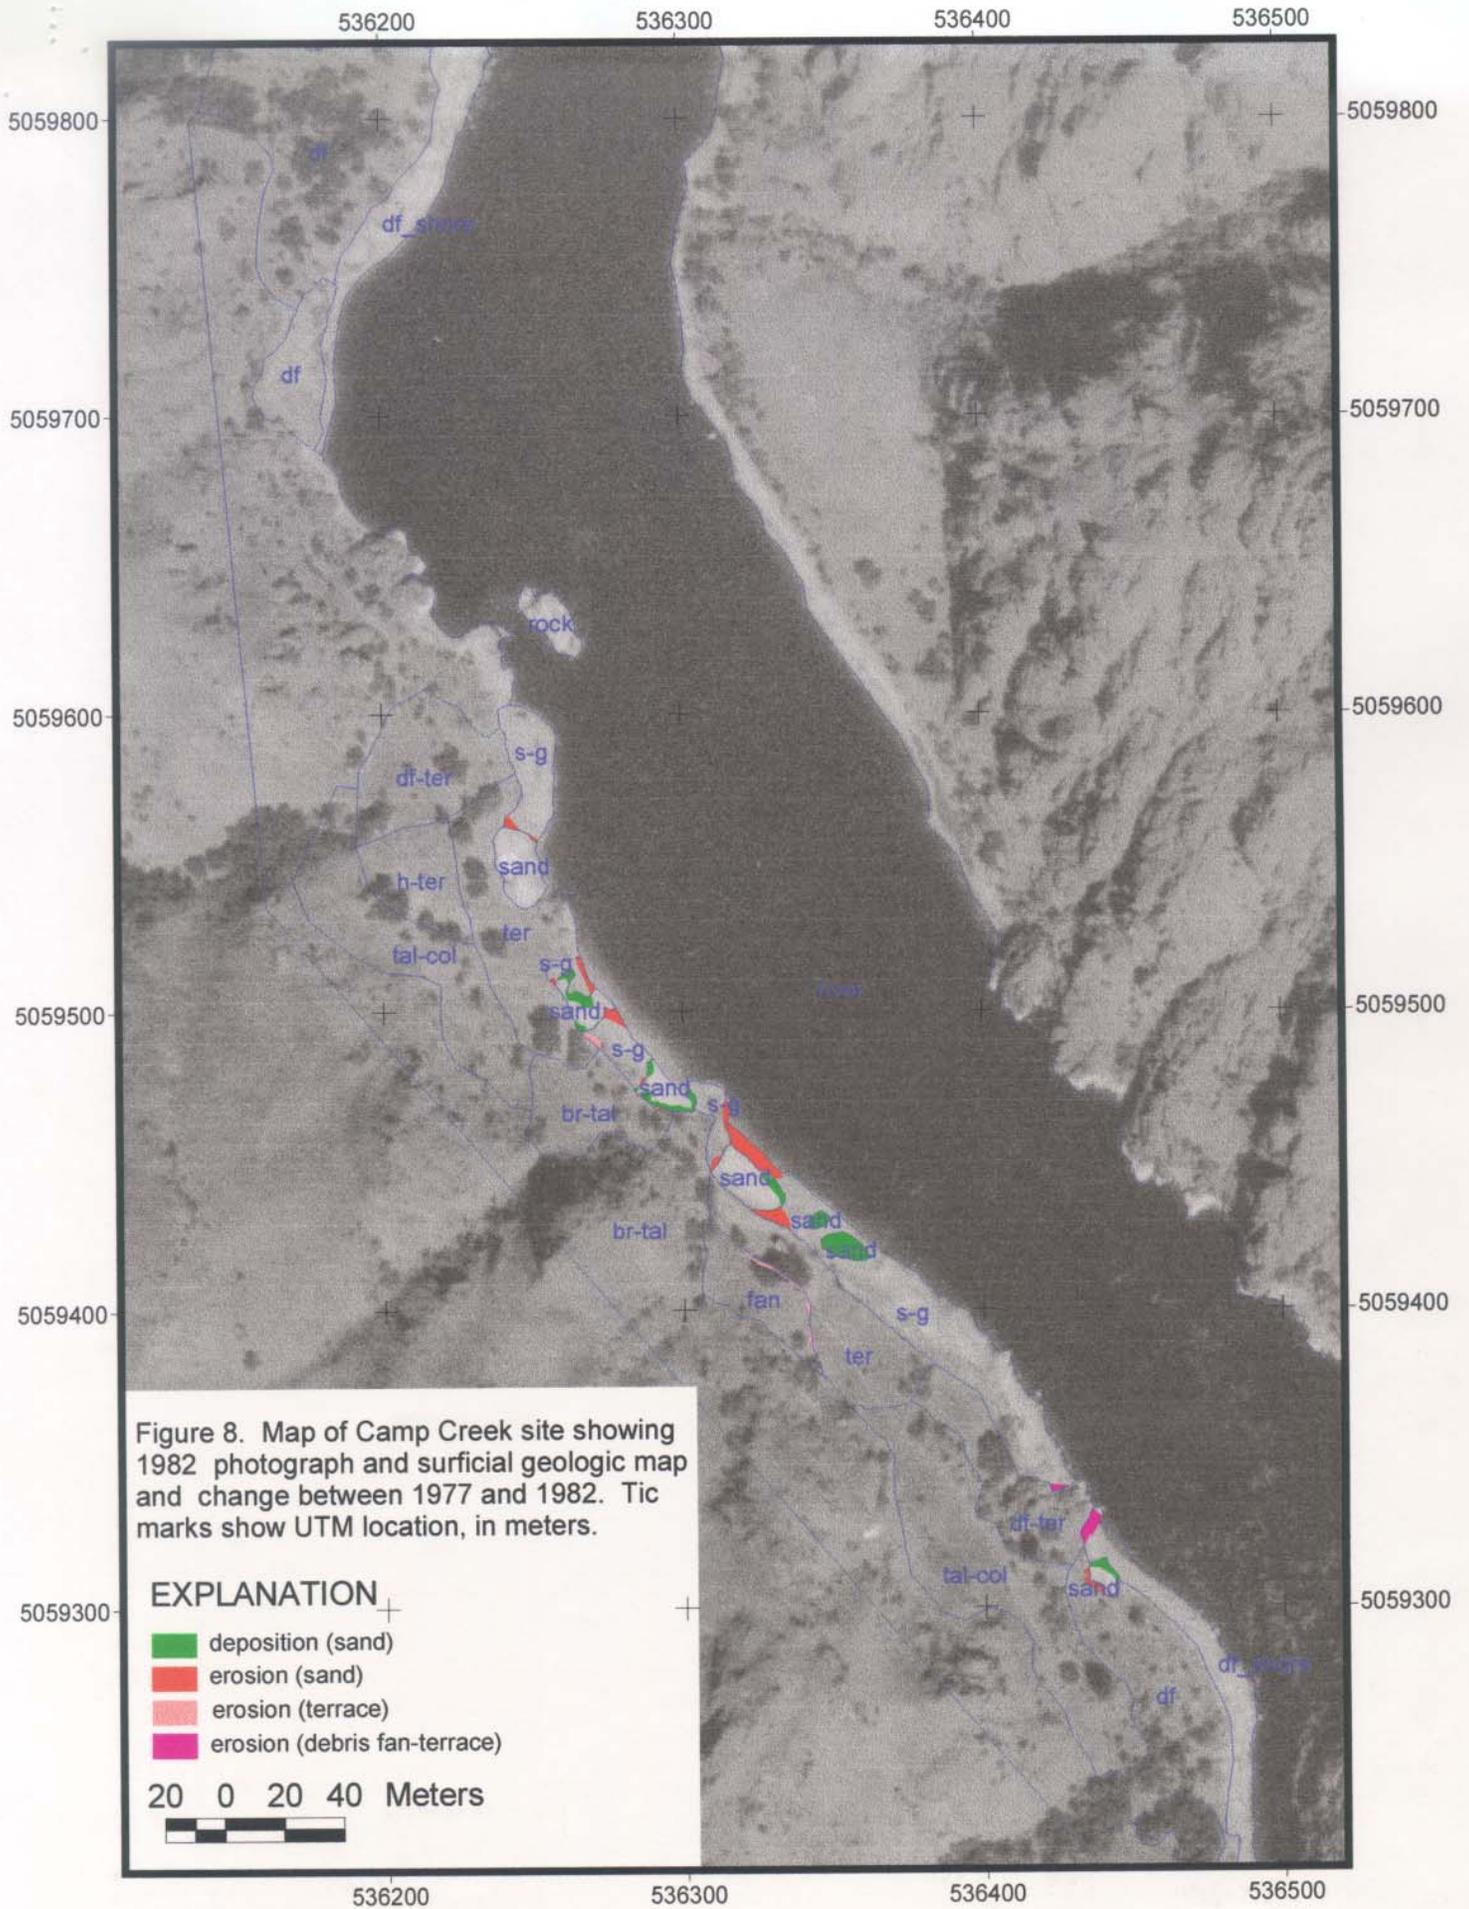
Between 1977 and 1982, the margins of some of the larger sand bars eroded and the area armored by gravel increased (the areas mapped red in Figure 8). Deposition of sand occurred in a few places where sand bars had eroded between 1964 and 1977. Between 1982 and 1996, there was continued erosion of the terraces and sand bars (Figure 9). Deposition of sand occurred at a few locations, usually adjacent to terrace deposits.

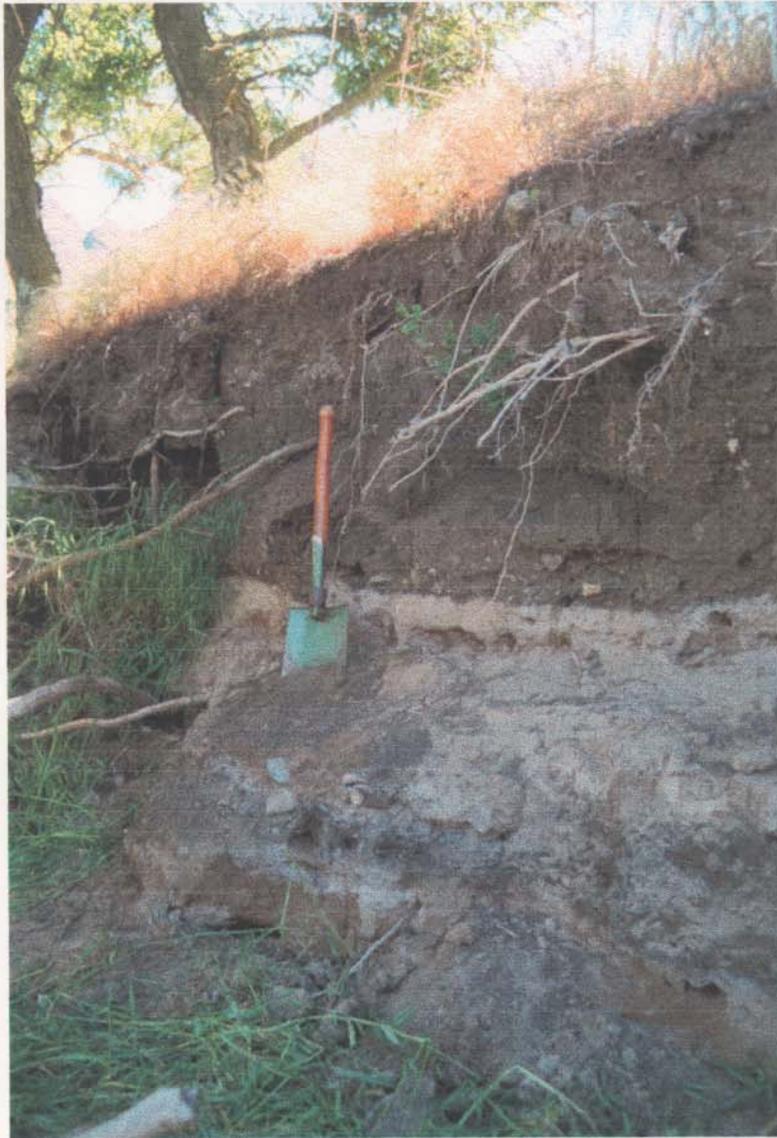
Figure 10. Photograph of exposed cutbank at Tin Shed site, showing interbedded Snake River fluvial deposits and hillslope deposits. In this photograph the hillslope deposits overlie the fluvial and sand deposits.

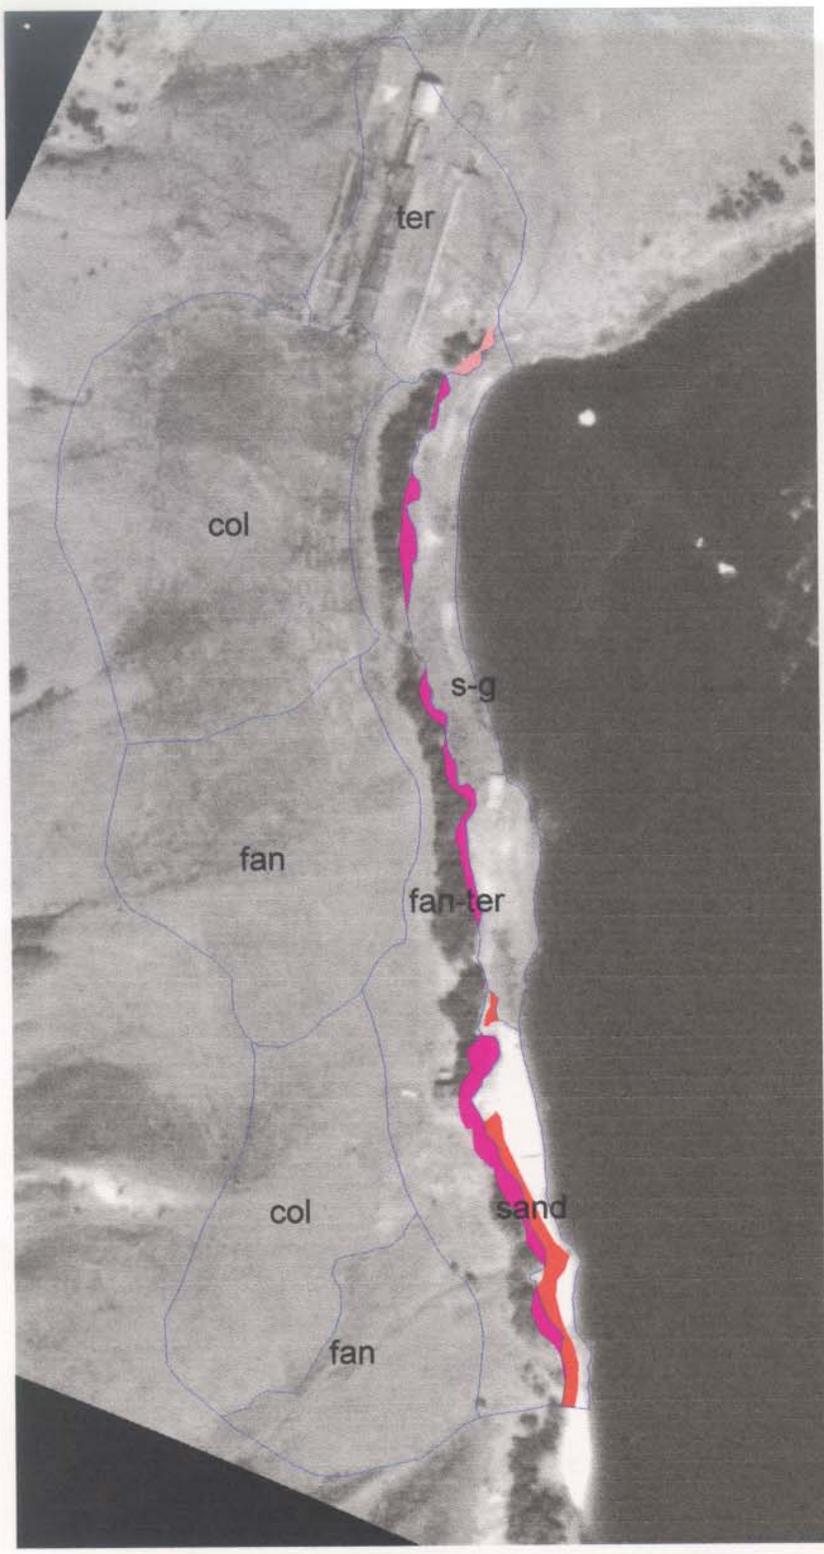
Alluvial terraces and fan-terraces at the Tin Shed site have extensively eroded by cutbank retreat since 1964; bare sand deposits have eroded as well (Figure 11). In contrast to Camp Creek, significant erosion of the terrace deposits did not begin until after 1982, but sand bar erosion began much earlier. Erosion of the terrace upstream from the tin shed itself (mapped as “shed”) occurred between 1982 and 1991 (Figure 12), and erosion downstream from the shed occurred between 1991 and 1996 (Figure 13). The greatest area of sand bar erosion occurred between 1964 and 1982 (Figure 14); continued erosion occurred between 1982 and 1991 (Figure 12).

Figure 11. Map of Tin Shed site showing 1964 photograph and mapping and change between 1964 and 1996.

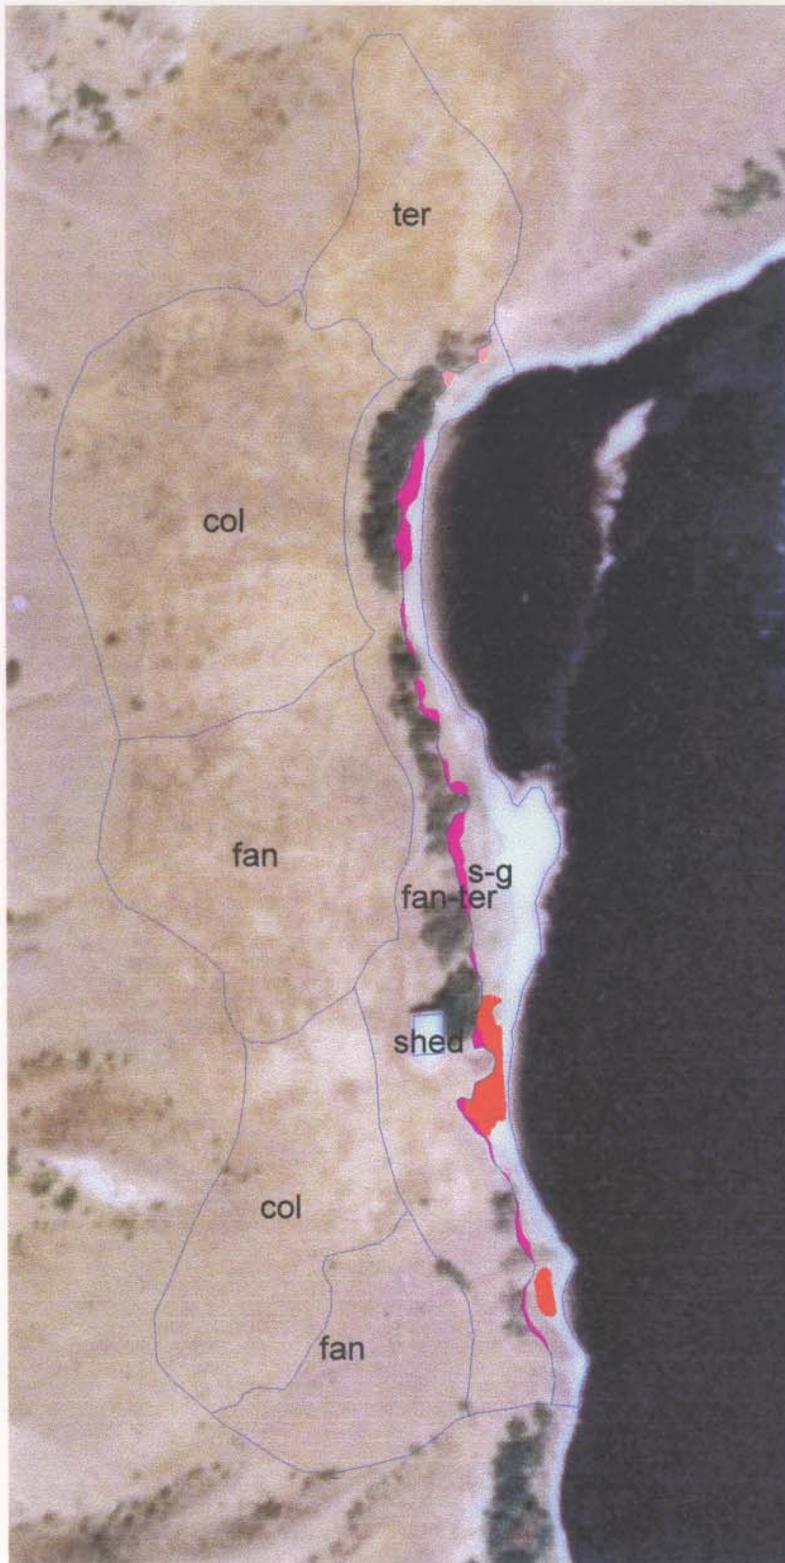
Figure 12. Map of Tin Shed site showing 1991 photograph and surficial geologic map and change between 1982 and 1991.

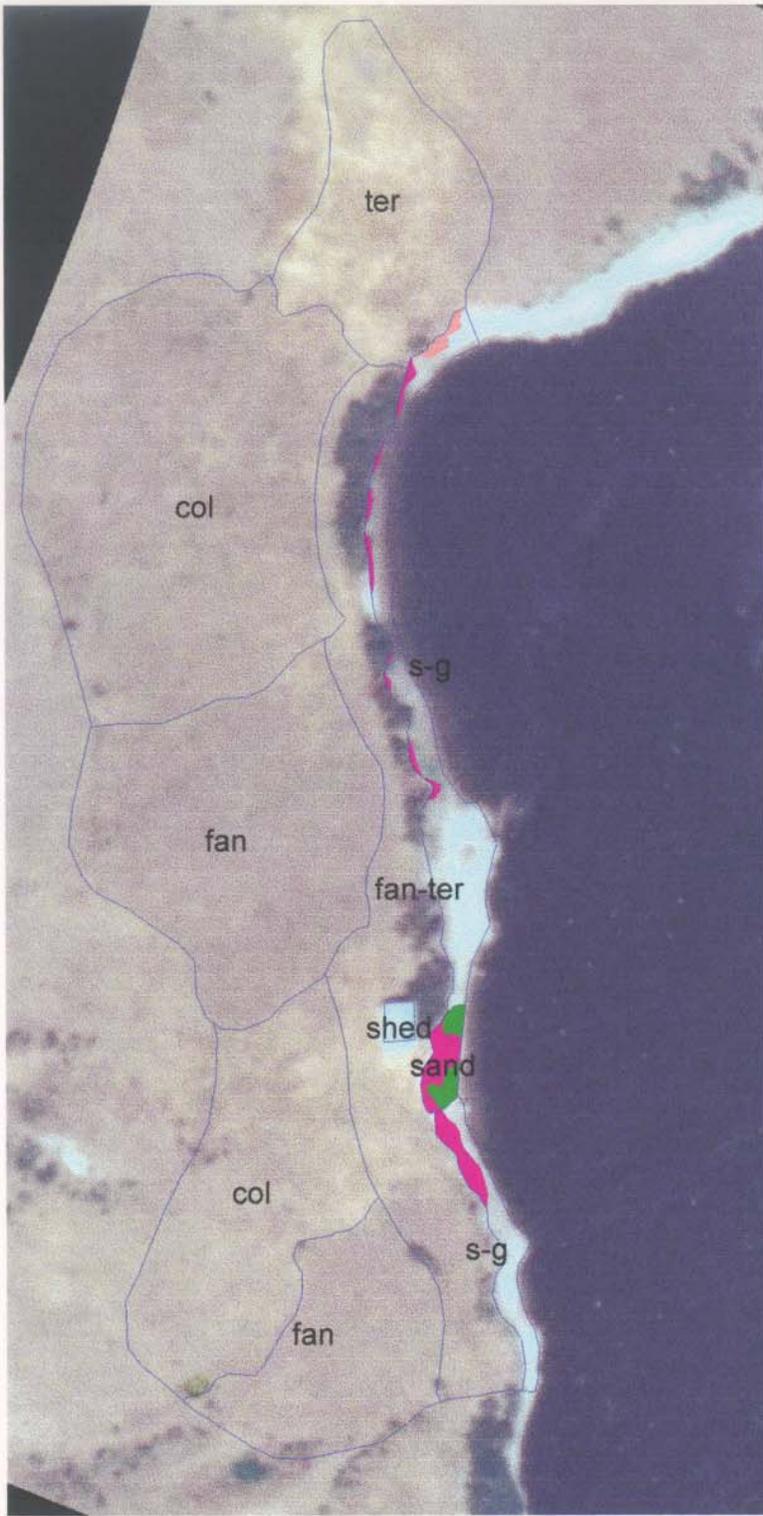
Figure 13. Map of Tin Shed site showing 1996 photograph and surficial geologic map and change between 1991 and 1996.

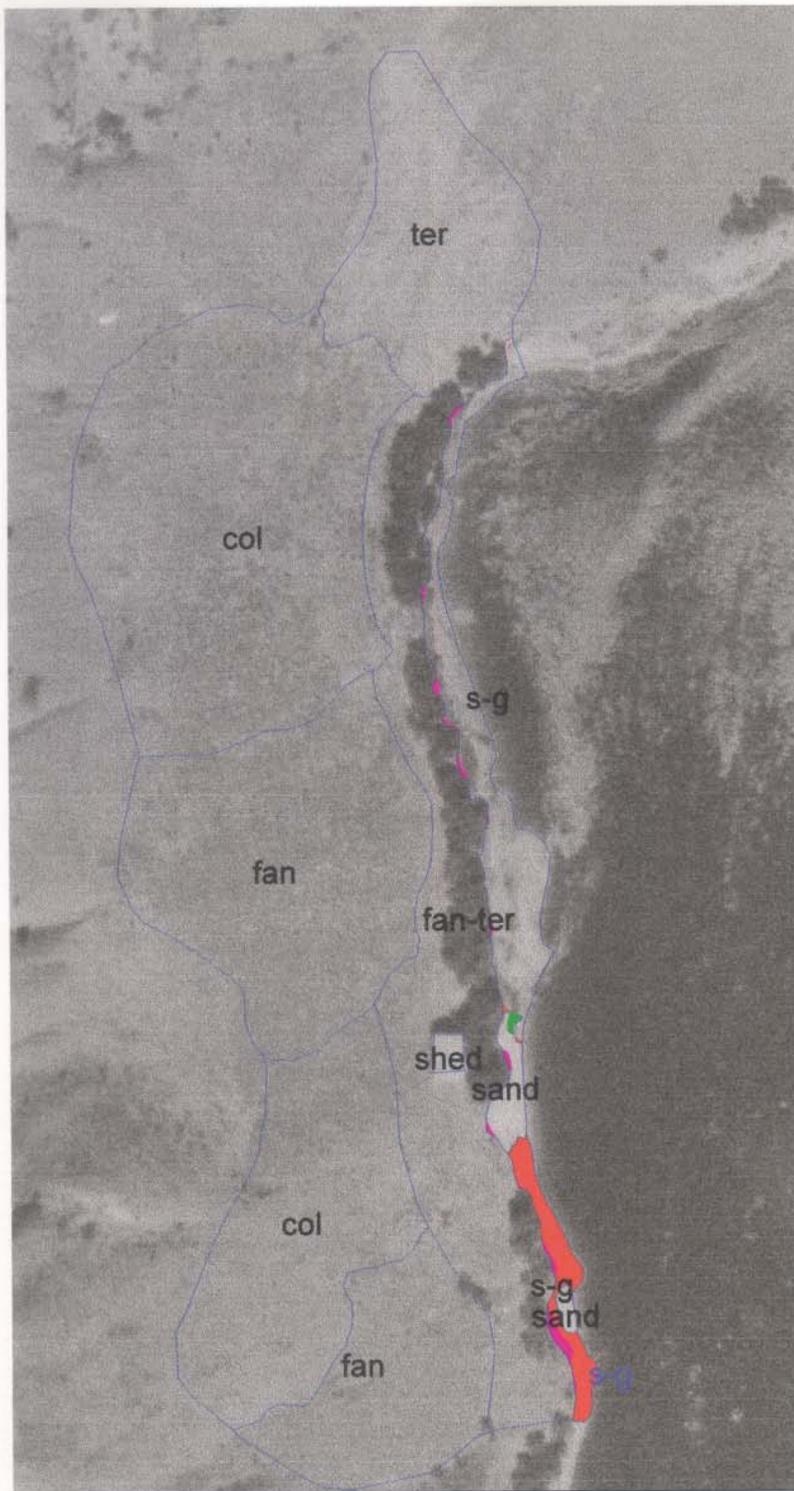
Figure 14. Map of Tin Shed site showing 1982 photograph and surficial geologic map and change between 1964 and 1982.

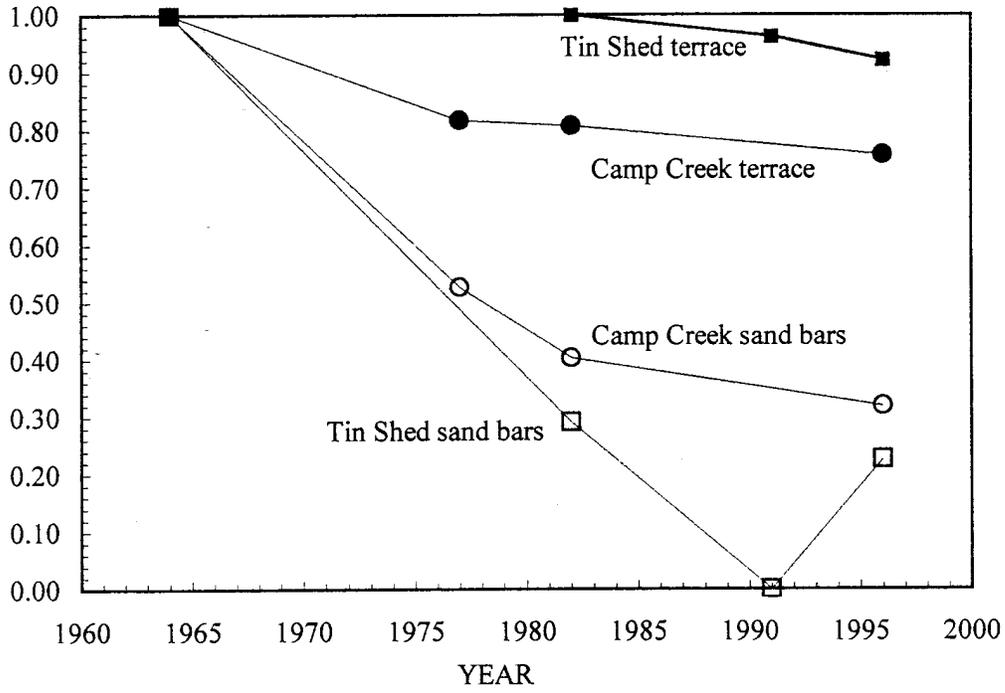
Erosion of the bare sand deposits has been extensive at both sites and occurred in the first interval between air photos (Figure 15). As the locations of sand deposition became armored, the rate of erosion declined. This pattern is similar to the pattern of sand bar erosion described by Grams (1991) for all sand bars in Hells Canyon upstream from the Salmon River confluence. At the Tin Shed site, erosion of the sand deposits preceded the erosion of the terrace deposits while the bare sand and adjacent terrace deposits eroded during the same interval at Camp Creek. There is no evidence to suggest that terrace erosion preceded sand bar erosion at either site.

Figure 15. Area of terrace, fan-terrace, and sand deposits at the study sites between 1964 and 1996, expressed as a ratio of the area measured in a given year to the area measured in 1964.
