DEGRADATION OF ALLUVIAL SAND BARS ALONG THE SNAKE RIVER
BELOW HELLS CANYON DAM, HELLS CANYON
NATIONAL RECREATION AREA, IDAHO

Paul E. Grams and John C. Schmidt

Department of Geology
Middlebury College
Middlebury, Vermont 05753
February 1991

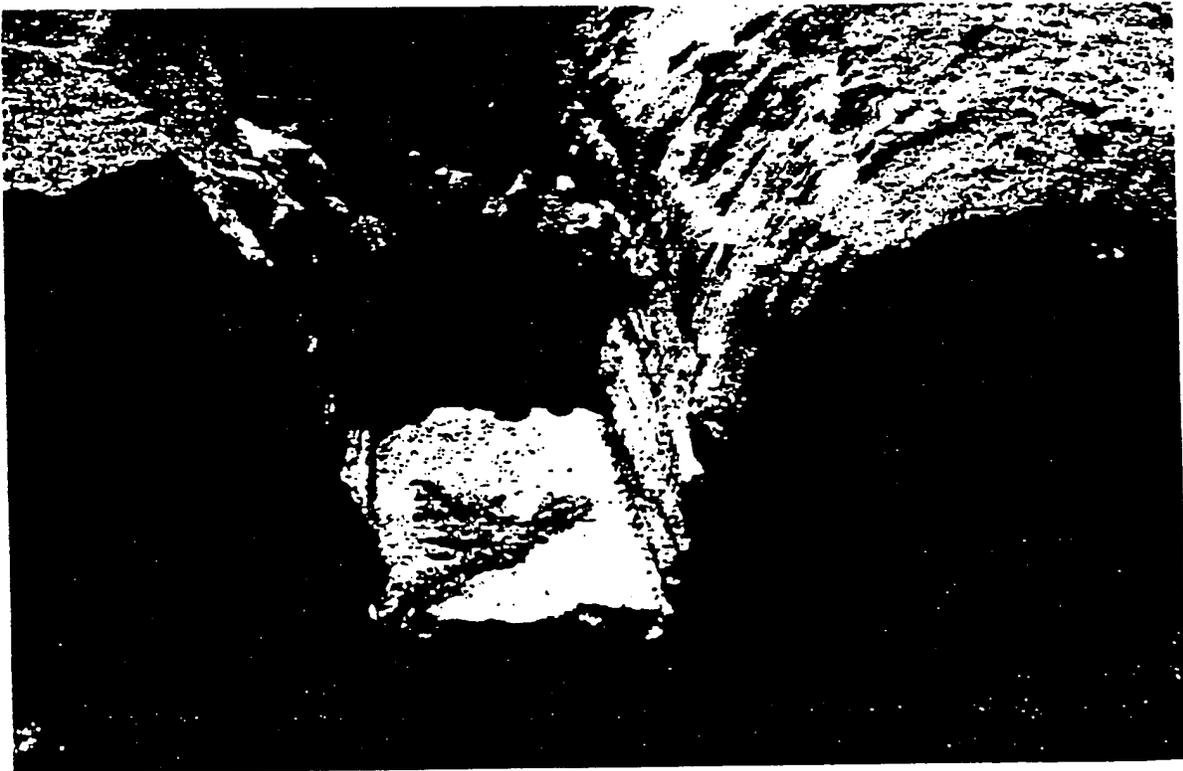
Figure 23. -- Photograph of exposed trench at Salt Creek Bar, summer 1990. Dune cross-bedding is visible, arrow indicates dune migration direction.

Bar sedimentology was examined in trenches along the flat platform of the sand bar. The upper 1.8 ft of the bar is composed of medium-grained sand deposited in four sequences of three-dimensional, dune-form cross-bedding (Figure 23). The size of the structures, the grain-size, and the three-dimensional form indicate high transport rate and high velocity at the time of deposition. This suggest that deposition occurred during an event of relatively high flow. The dune migration directions are on-shore and upstream. As the bar built it migrated towards the bank and the return channel. Figure 24 shows these units and the pattern of bar migration. Underlying the sequence of dunes is a mud layer. This deposit is likely a remnant of a pre-regulation flood, as there is no apparent
