**Sand Bar Erosion and Deposition on the Snake River
in Hells Canyon Between 1990 and 1998**

FINAL REPORT

September 27, 1999

Paul E. Grams and John C. Schmidt
Department of Geography and Earth Resources
Utah State University
Logan, Utah 84322-5240

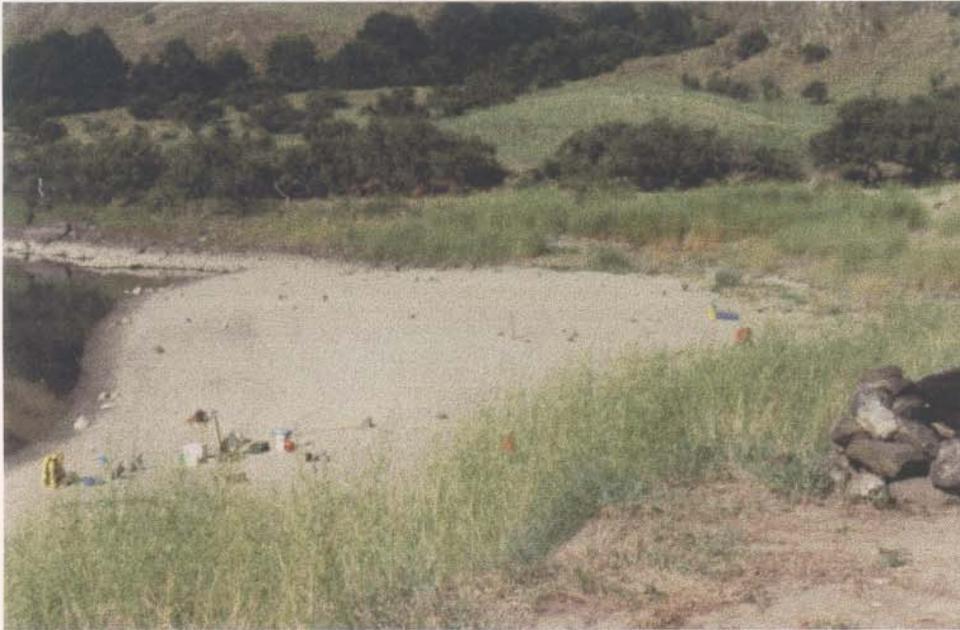
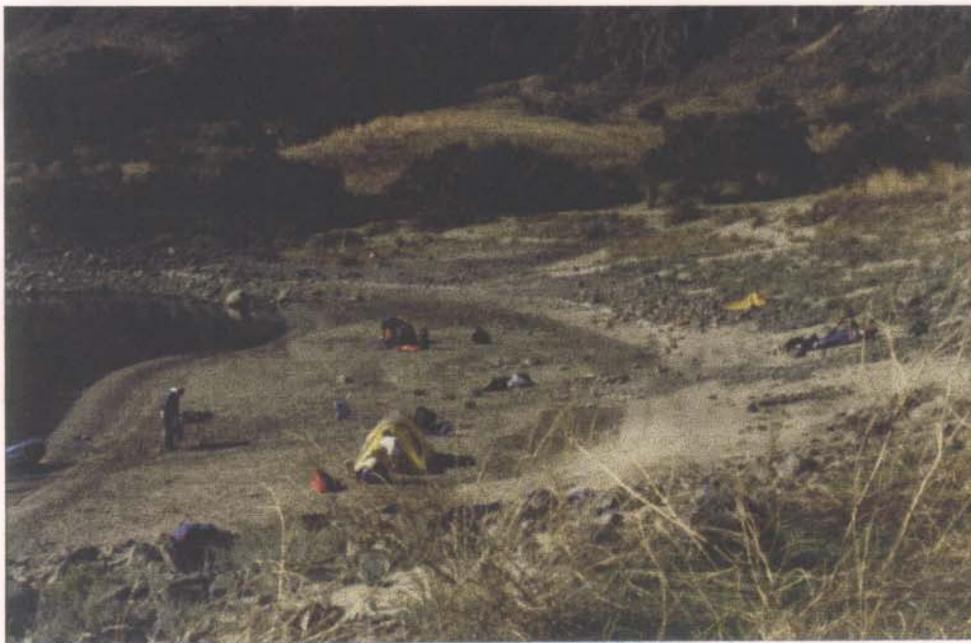
Figure 11. Matched photographs of Salt Creek Bar taken in 1990 (a) and 1998 (b). The view is upstream and shows erosion of the cutbank in the foreground and an increase in the area of the bar that is armored by gravel in the background. The location the photographs were taken from is shown in Figure 8.

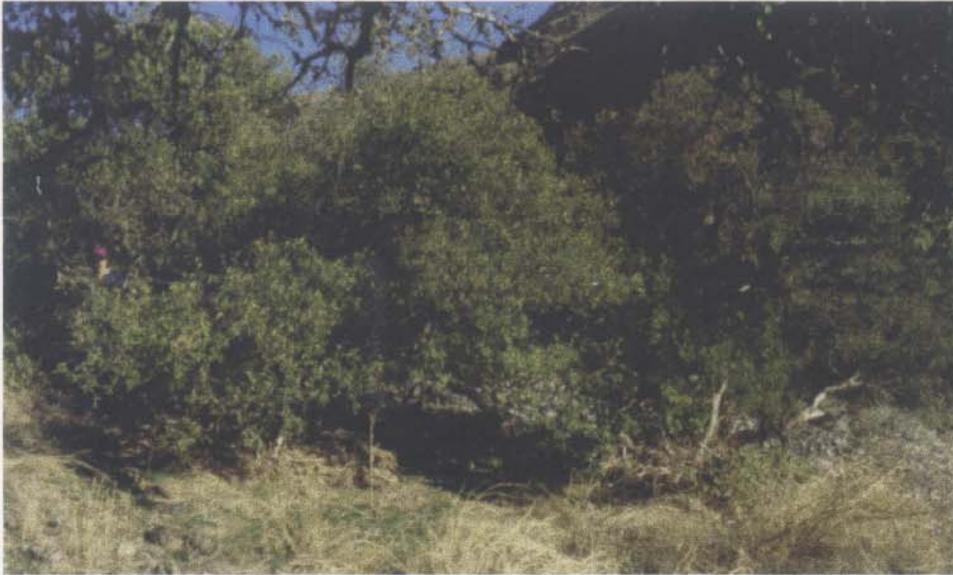
Figure 12. Photograph showing features used to identify the elevation of the 1998 peak discharge at Salt Creek Bar. The location the photograph was taken from is shown in Figure 8.

The discharge required to inundate the terrace was estimated by locating indicators of the 1998 peak discharge, which was $2,675 \text{ m}^3/\text{s}$. High-water marks consisted of piles of fresh driftwood and duff, often with grass wrapped around small trees (Figure 12). The peak discharge partially inundated the terrace at the upstream and

downstream ends of the bar and was approximately even with the top of the active cutbank in the center of the bar where a high sand dune separates the terrace from the bar. Erosion of the terrace between 1990 and 1998 occurred up to and slightly above the elevation of the 1998 peak discharge. Erosion above this level likely occurred in January 1997 when the peak discharge was 2,917 m³/s.

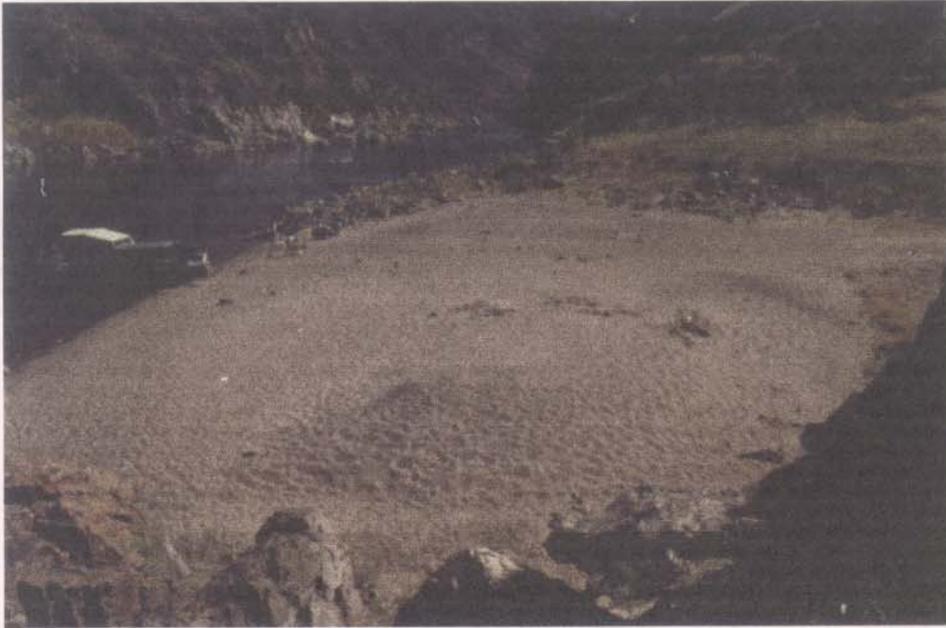
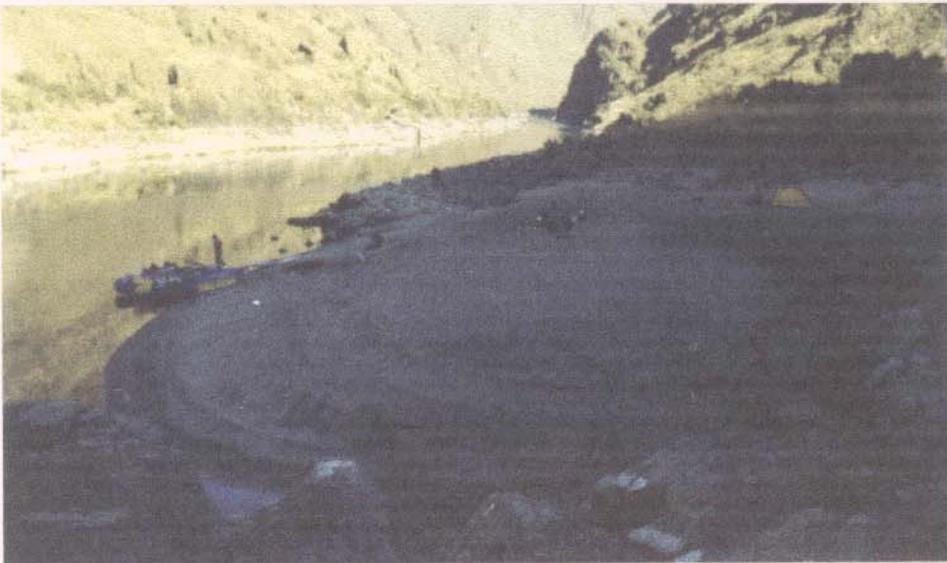
Figure 18. Matched photographs of China bar taken in 1990 (a) and 1998 (b). The location the photographs were taken from is shown in Figure 17.
