**Technology &
Development
Program**

Surviving Fire Entrapments

Comparing Conditions Inside Vehicles and Fire Shelters

September 1997
7E62P87–Vehicle Entrapment

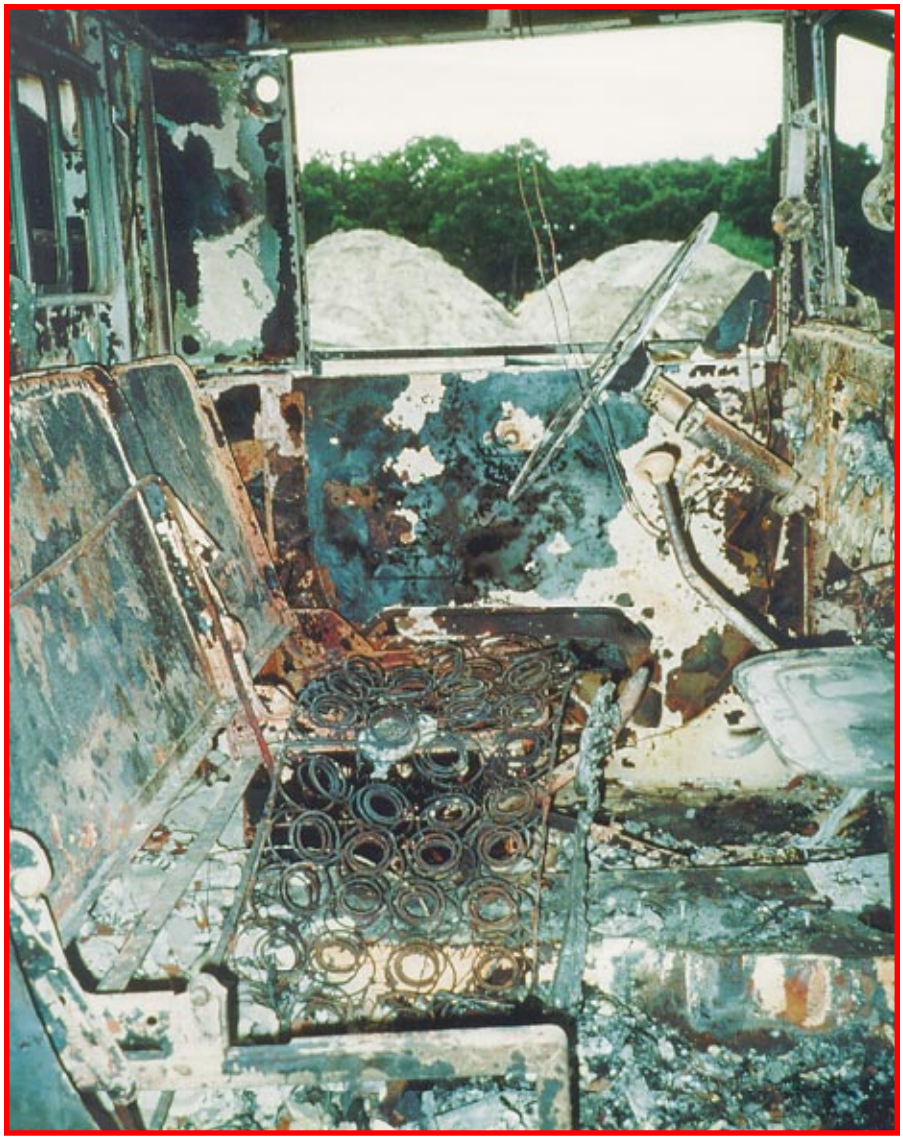
Figure 1—This engine burned during the 1995 fires on Long Island. Although many engines were destroyed, all firefighters escaped without injuries.

Figure 2—The cab interior of the same engine burned during the 1995 fires on Long Island.

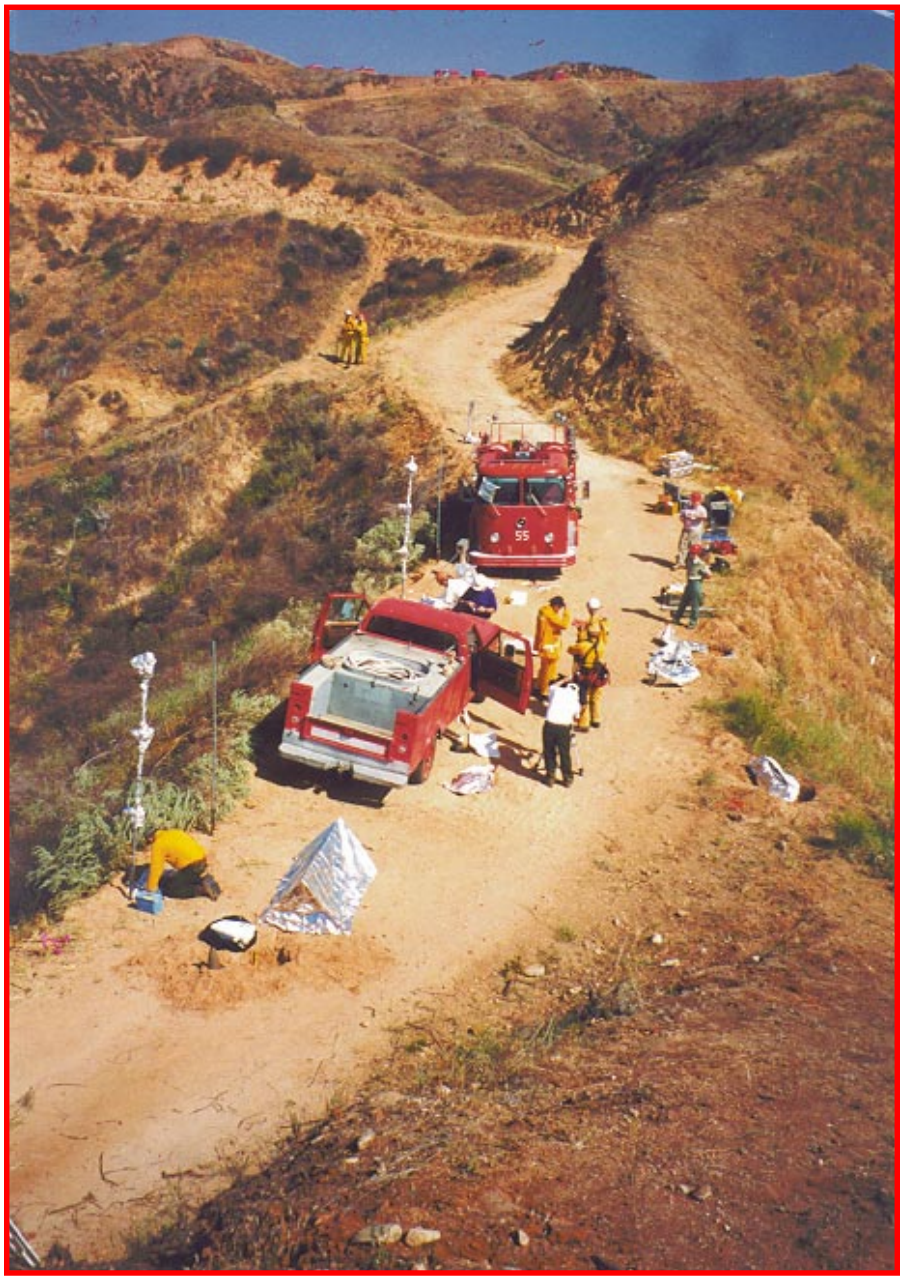
The study was designed to quantify the conditions that existed inside the cab of an engine and inside a fire shelter—at the same time—during a wildfire burnover (Figure 3).

Figure 3—Layout for the June 5 burn in Los Angeles County.

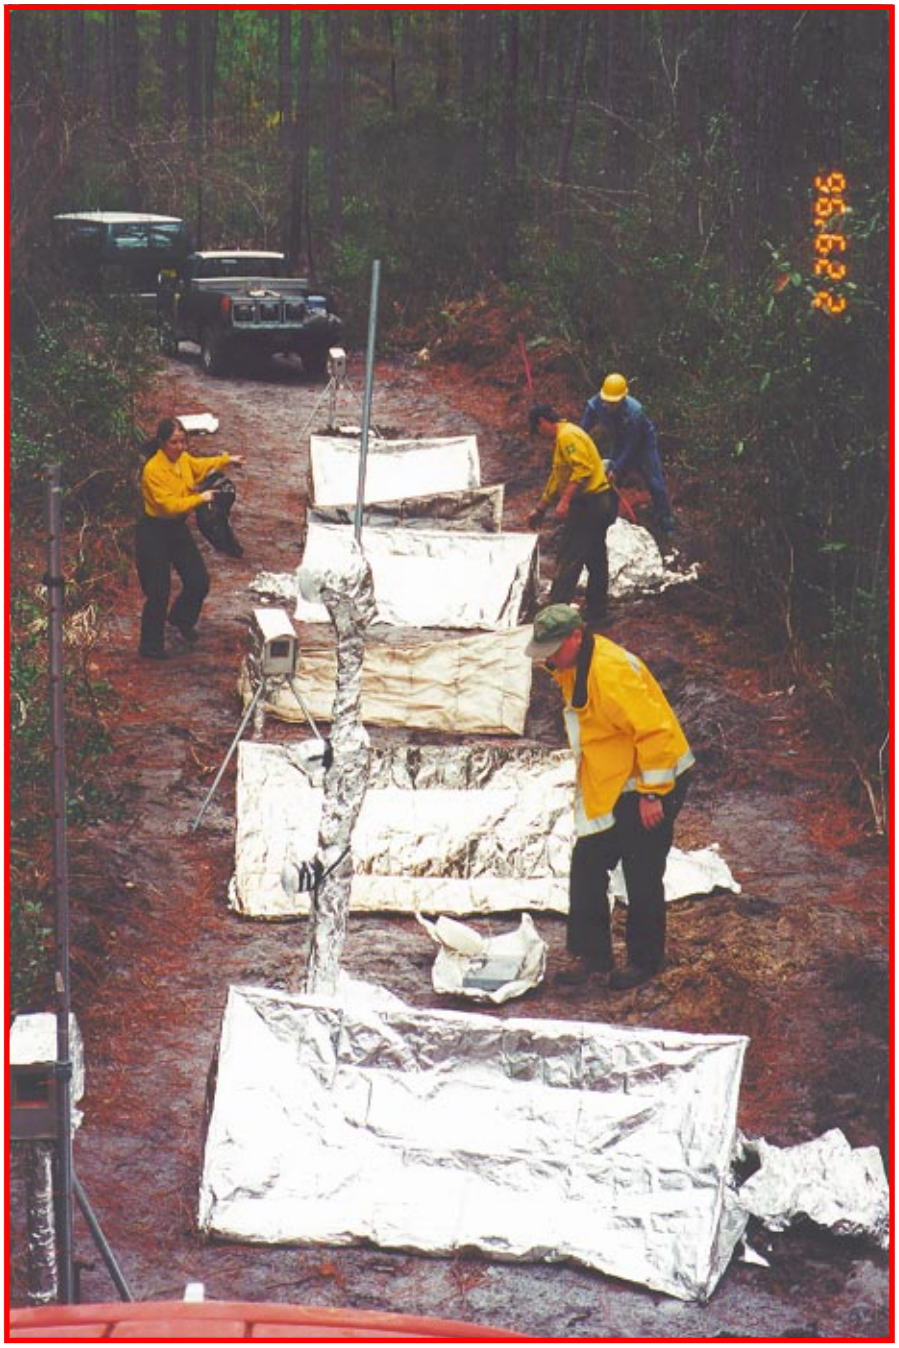
- Surface temperatures on the outside and inside surfaces of the standard fire shelters and prototype stainless steel fire shelters (Figure 4)

Figure 4—Several types of fire shelters were tested, including the standard Forest Service fire shelter and prototypes from MTDC and a private firm.
