Sand Bar and Terrace Erosion Between 1964 and 1996 at the Tin Shed and Camp Creek  
Cultural Resource Sites on the Snake River in Hells Canyon

FINAL REPORT

August 20, 1999

Paul E. Grams and John C. Schmidt  
Department of Geography and Earth Resources  
Utah State University  
Logan, Utah 84322-5240

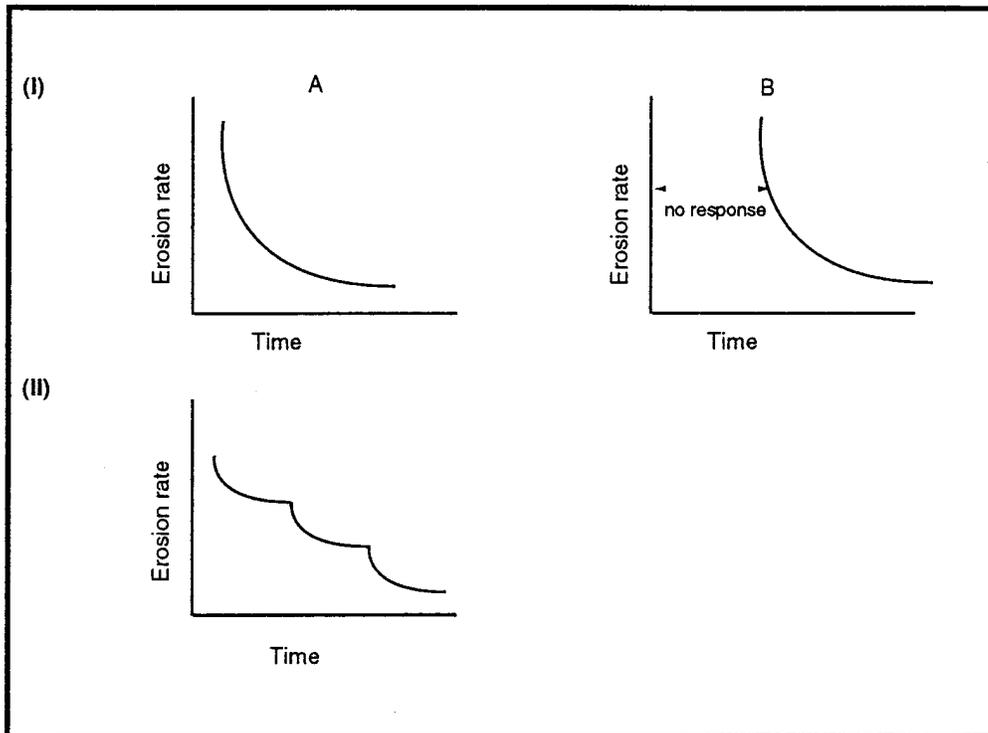
We have measured two styles of cutbank retreat of alluvial terraces in Hells Canyon. One style is a steadily declining rate of erosion with time and the second style has several such discrete periods (Figure 16).

The first style is consistent with the data presented in this report for Camp Creek. Erosion of the terraces began at Camp Creek after 1964 and declined with time. Grams and Schmidt (1999) showed that bank retreat at Fish Trap Bar was similar to that measured at Camp Creek. The second style of erosion was measured at Salt Creek Bar where there were two episodes of high rates of erosion separated by a period of less erosion (Figure 17). Erosion of the terraces at Tin Shed did not begin until after 1982, and it is too soon to determine whether the erosion rate is increasing or decreasing. The difference between the Camp Creek and Tin Shed sites is that there was a period of no response between 1964 and 1982 before erosion began at Tin Shed. The Tin Shed site, therefore, may be following either style of erosion.

Figure 16. Conceptual model showing proposed alternative styles of terrace cutbank erosion. Style I is rapid initial erosion followed by decreasing rates of erosion. In style IA, the erosion is initiated soon after streamflow regulation; in style IB, there is an unknown lag between streamflow regulation and the inception of erosion. In style II, high rates of erosion recur following periods of low rates of erosion.

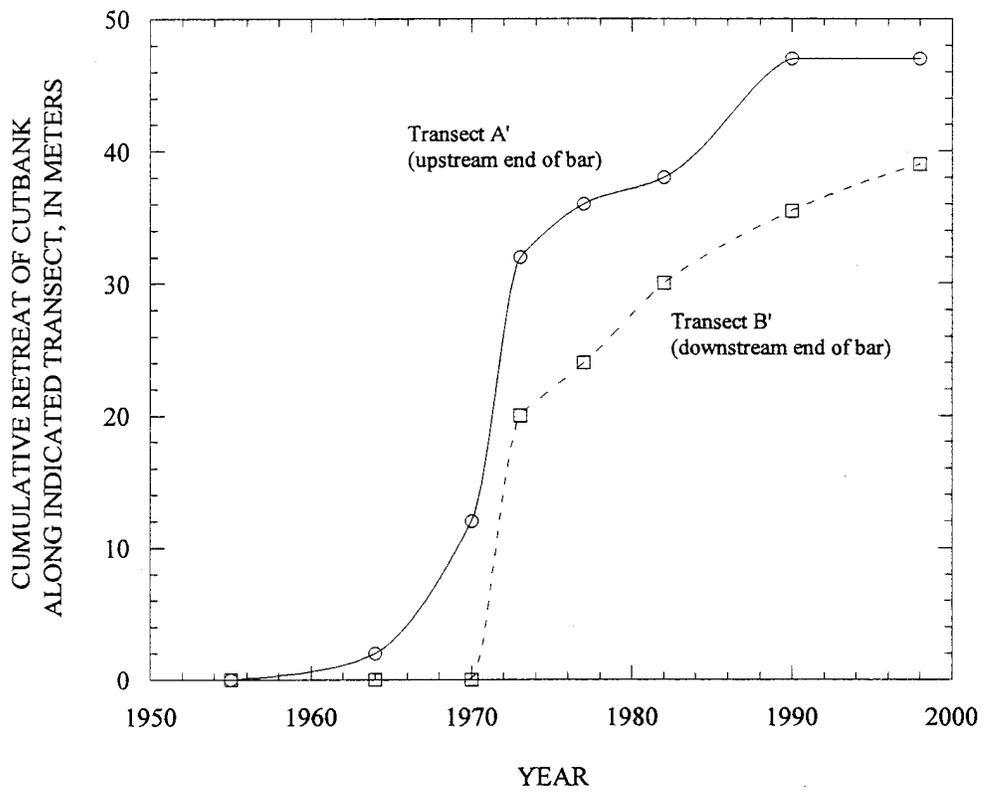
Figure 17. Episodic high rates of erosion (style II) measured at Salt Creek Bar (from Grams and Schmidt, 1999).
