Supplement to the FEIS

1.1 PURPOSE OF THIS SUPPLEMENT

The Viveash Fire Salvage Final Environmental Impact Statement (FEIS) was completed in June of 2002 and the Record of Decision signed on July 24th, 2002. The Regional Forester received a number of appeals of this decision. On November 4th, 2002 the Appeal Deciding Officer affirmed the Responsible Official's decision on the Viveash Fire Salvage and reversed the decision on the independent road management activities with the following direction:

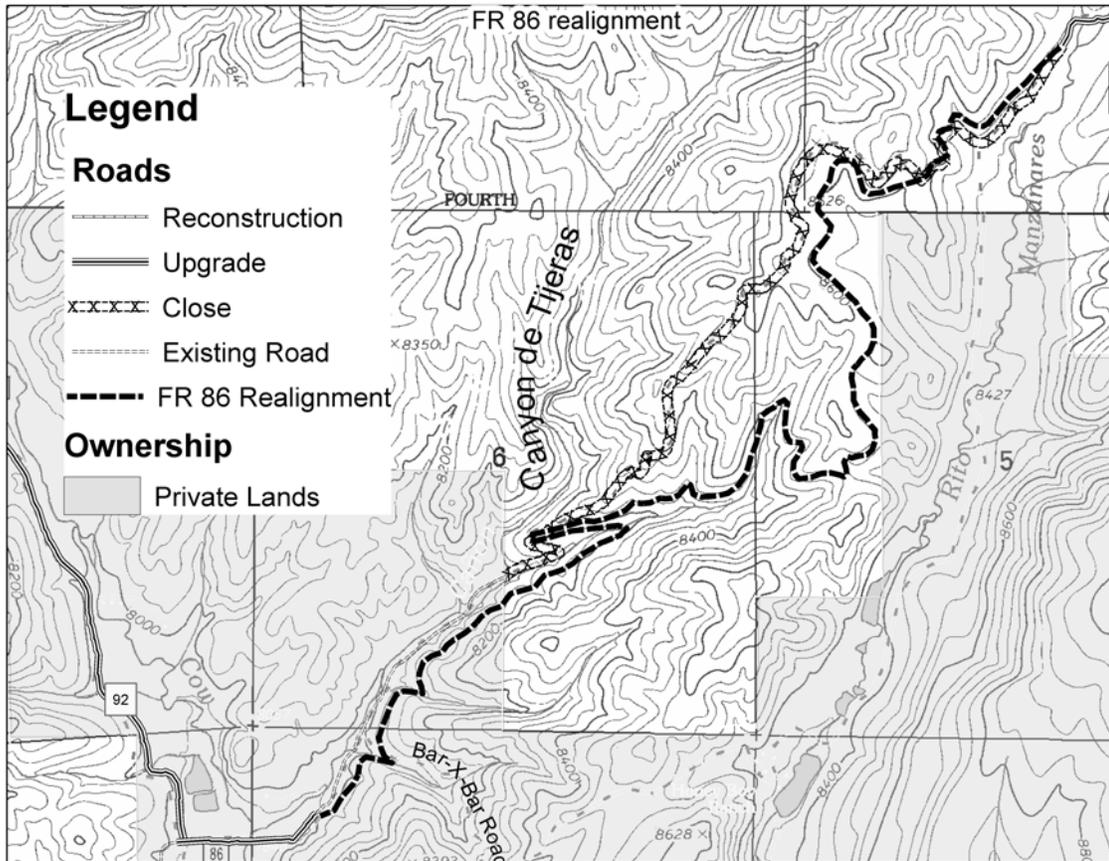
Figure 2: Road 86 Realignment map

This road section lies within the Tijeras sub watershed, less than ½ mile northeast of the intersection of FR 86 with FR 92. See Figure 2, on right. The area receives light recreation use.

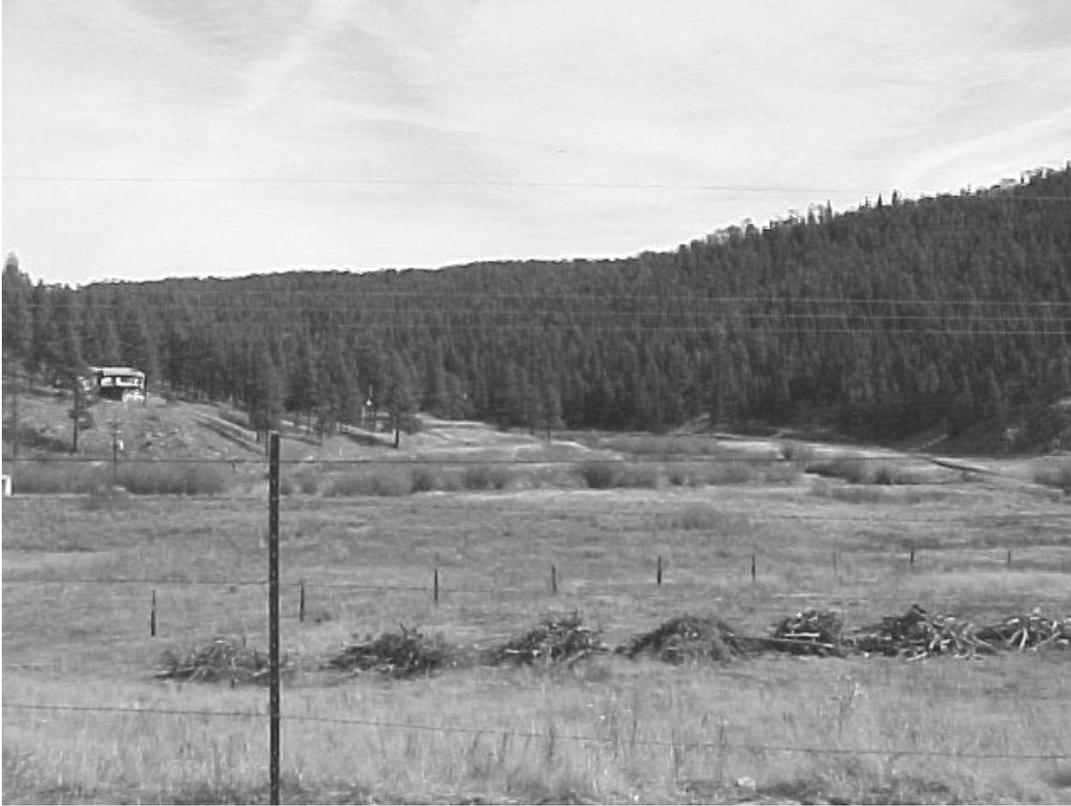
Figure 3:View across Cow Creek from FR 92 looking up Tijeras canyon.

The existing viewshed consists of riparian meadow. The foreground is dotted with private homes and cabins, and fences. Steep sided, heavily forested hills rise on either side, narrowing as one proceeds northeast. At the far end of this segment, the road switchbacks up a hillside, to run along a ridge.

Currently the section of existing road runs in a drainage bottom through private land and does not have an authorized right of way. Operationally it is a Maintenance Level 2 Road with an objective of Maintenance Level 3. (Personal communication with Pat Leyba, Forest Engineer, SFNF) It is not heavily used but often rutted and in places is 3' lower than the surrounding land. It crosses Tijeras Creek over culverts and rock gabions. The road is fenced with barbed wire on either side to contain traffic. When Tijeras Creek is at

high stage, it flows onto the road as it seeks the path of least resistance. Debris from the flooding and piles of dirt and rock removed from the road are noticeable along the 86 road corridor.

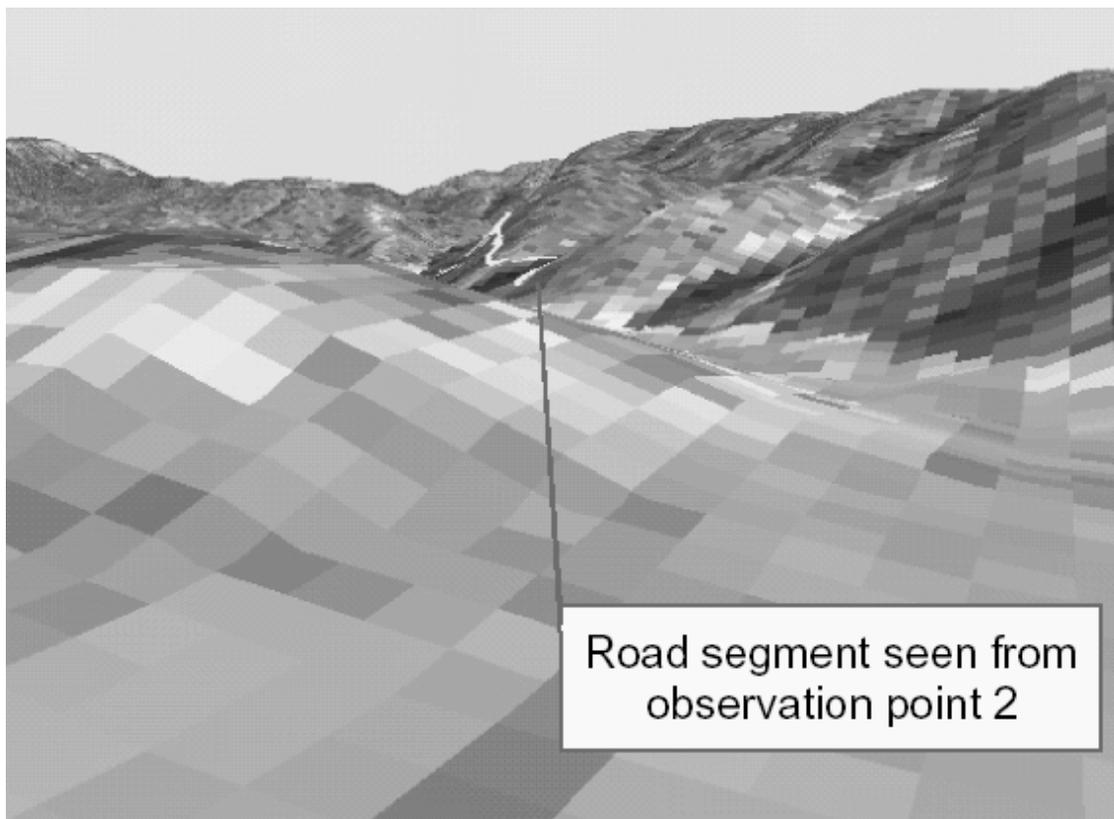
Figure 4: This computer generated view depicts the road as viewed from viewpoint 2

From those viewpoints, the new alignment undulates along the hillside minimizing the linear impact but it would not be visually subordinate to the landscape being viewed. The bench cuts would not maintain the form; color or texture of the surrounding densely forested hillsides. These cuts would look very light colored and chalky in contrast to the dark green and brown of the trees and organic litter on the top of undisturbed soil. The size of cut, which is almost continuous, average 12' but ranges from 6' to as tall as

- From the intersection with FR 92. There would now be two roads visible instead of one with about 1/3 mile visible.
- From the intersection with the Bar X Bar Ranch road which would be limited to 100'-200' segments in the viewshed.
- From viewpoint 2 (Fig. 1) with a sensitivity of level 1 (NF Land. Mgmt. Vol. 2, Ch. 1,
- The Visual Mgmt Sys, pp. 18-21), patches of cut and fill would be visible constantly.

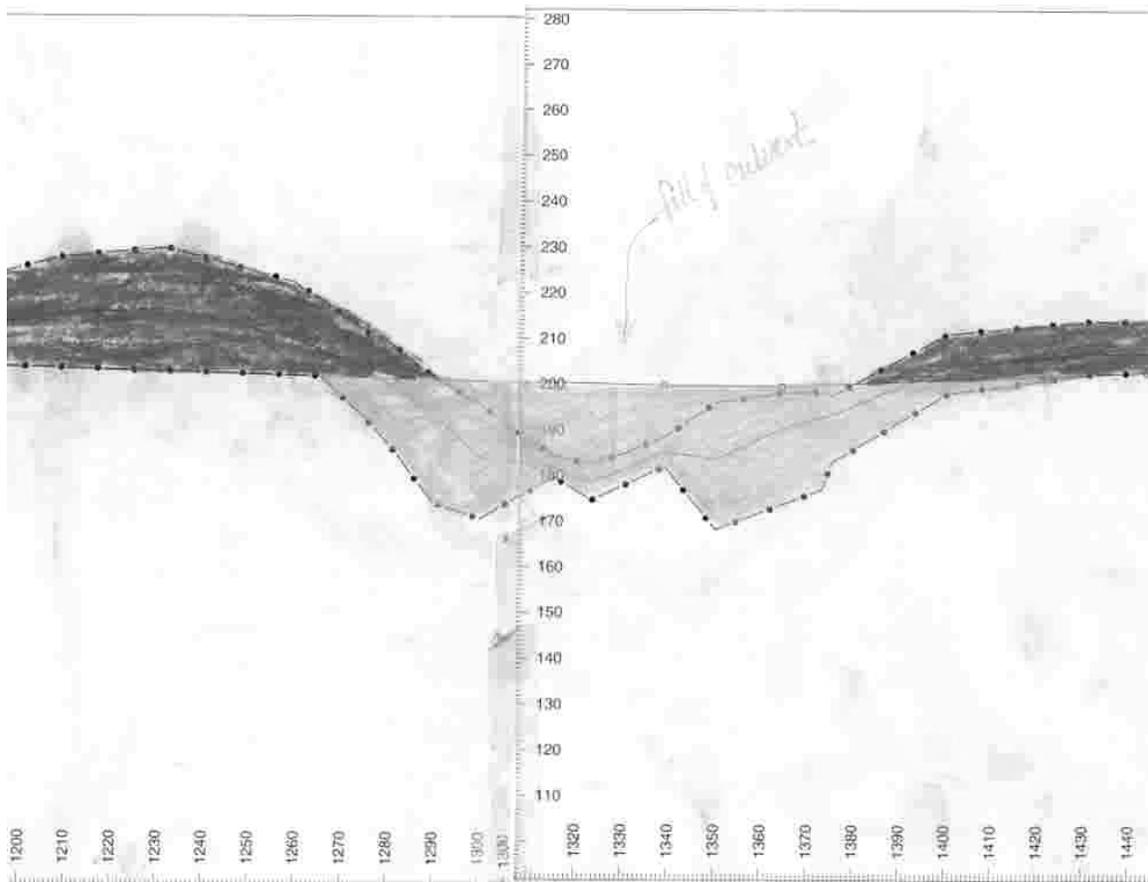
Figure 5: Segment of cut & fill for Tijeras section of Bull Creek Road. Scale indicates feet in equal horizontal and vertical scale.

27'(see figure 5 below for cut and fill profile). While these cuts are large, this impact would diminish to some extent after a year or two when ground vegetation would be expected to re-establish over the bare soil.

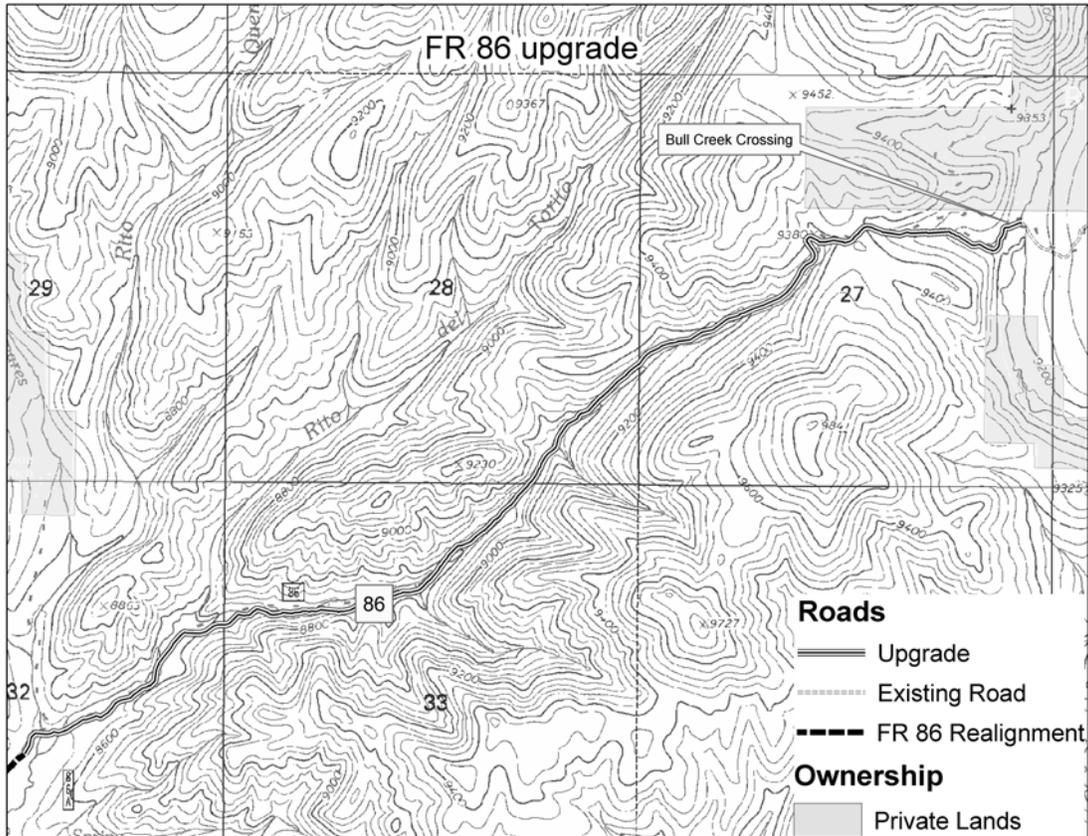
Figure 6: FR 86 upgrade map

The upgrading of the road will occur within the existing alignment. The landscape has a high degree of scenic integrity with only the road and powerline as man-made objects. It currently appears unaltered and natural. It is forested with mixed conifer lightly interspersed with scrub oak, a common and uniform vegetation pattern across the hillside. At Bull Creek the road fords the stream. A cabin, the road and crossing are foreground views as one proceeds down the road to the crossing.

This road section runs from Manzanares Creek to the Bull Creek Crossing, approximately 3 miles (Refer to figure 5 on next page). The area receives light recreation use.

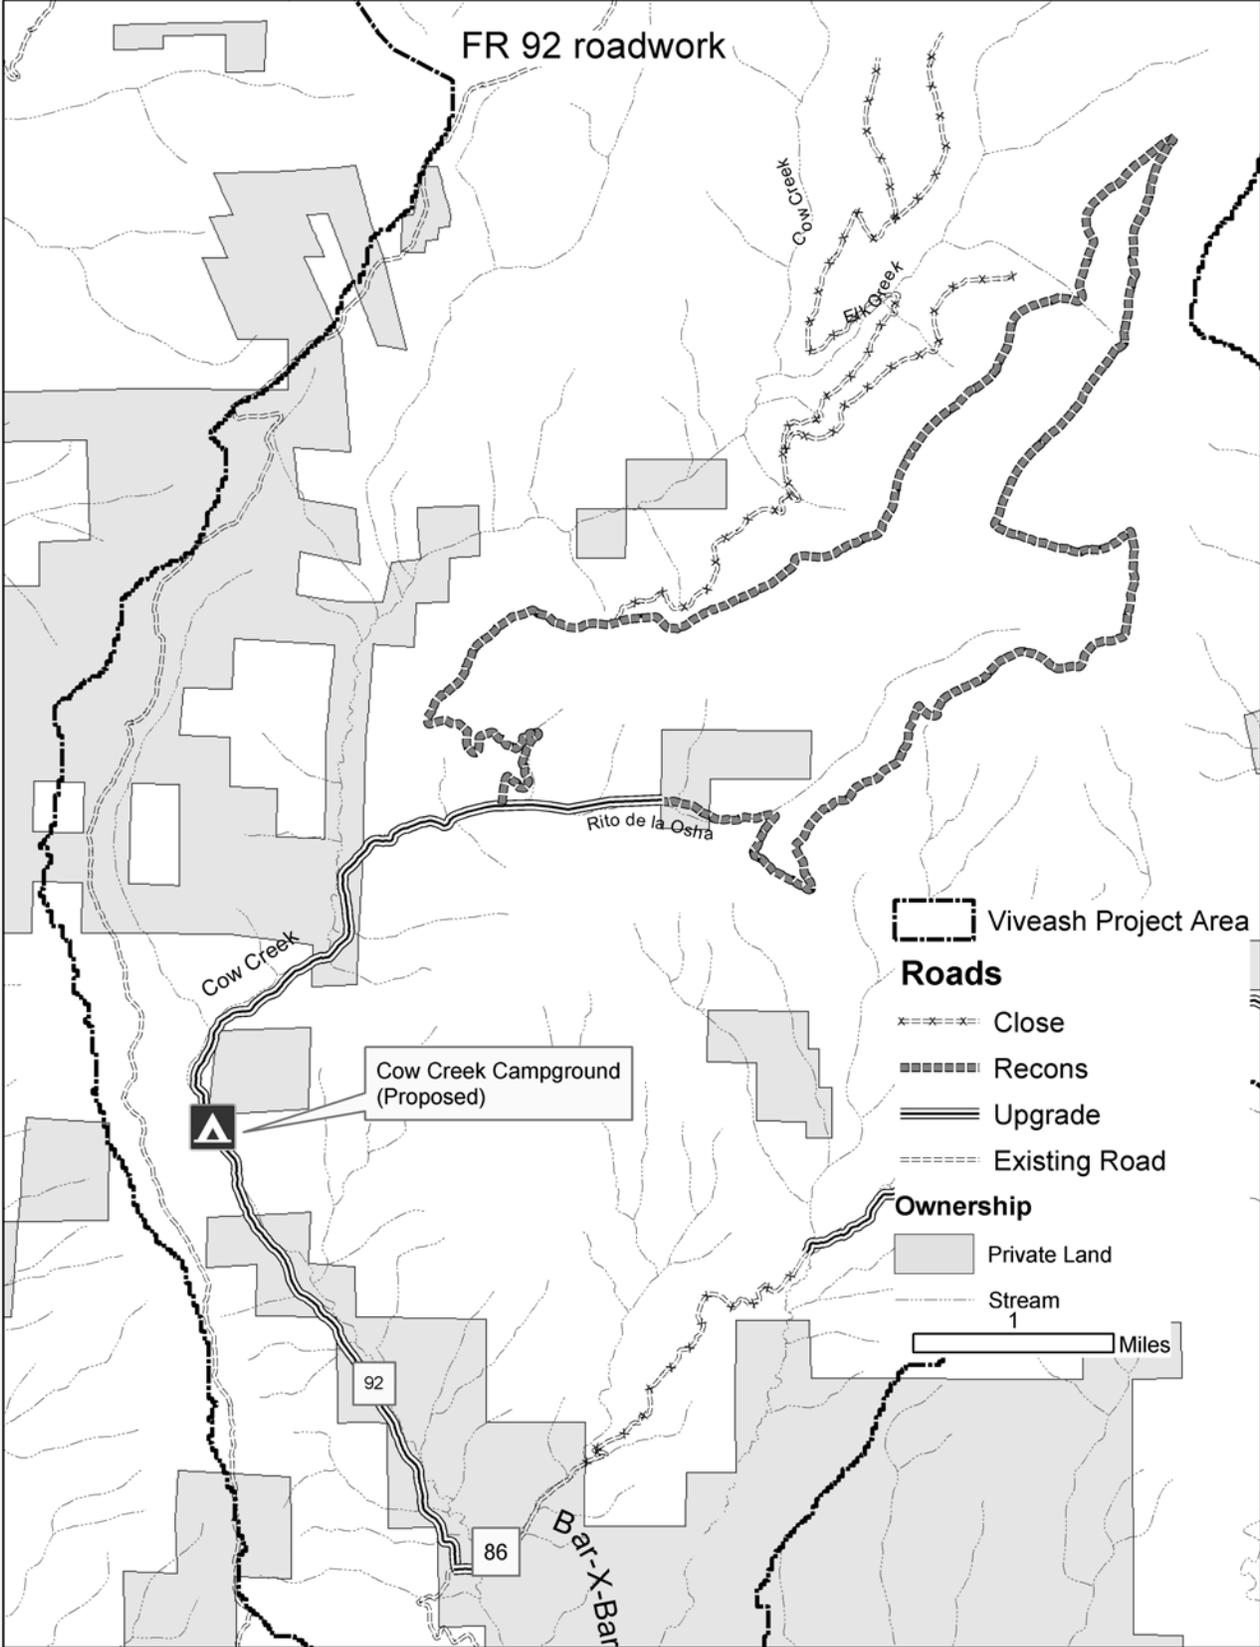
Figure 7: FR 92 Roadwork

The first 7 miles will be reconstructed/ realigned. Operationally the road in this area is a Maintenance Level 2 Road with an objective of Maintenance Level 3. (Personal communication with Pat Leyba, Forest Engineer, SFNF). For the first few miles of the road is along a riparian meadow. The foreground is here is dotted with private homes, cabins, and fences. Steep sided, heavily forested hills rise on either side, narrowing as one proceeds north. The road proceeds through a steep walled canyon, which was moderately to heavily burned in the Viveash fire. The road itself as well as the Cow Creek campground (dispersed) is the most visible man-made elements once in the canyon. The campground and the FR 92 comprise the sensitive viewpoints on the 92 system.

The upper 14 miles will only be reconstructed to a ML 2. This road receives very little recreation use except during hunting seasons. The skyline trail passes near the upper portion of the 92 road. A small portion of the road is barely visible through the burned trees.

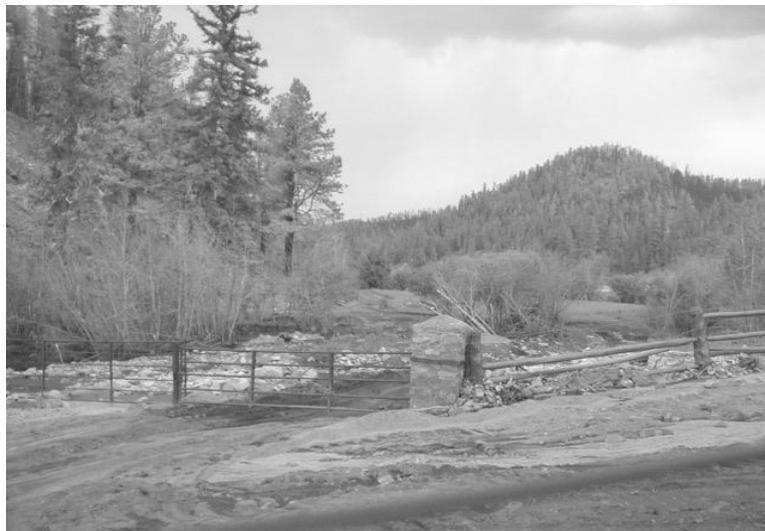
The 92 road was greatly affected by the Viveash Fire, which visually altered the landscape within the area. The fire and flooding effects were prominent along Cow Creek and the Rito de la Osha. Debris in the form of rocks, soil and wood was deposited on the roadbed after each flood event. This debris was removed and usually

Figure 8: Debris from the flooding along FR 92

piled along the road and is still visible in along

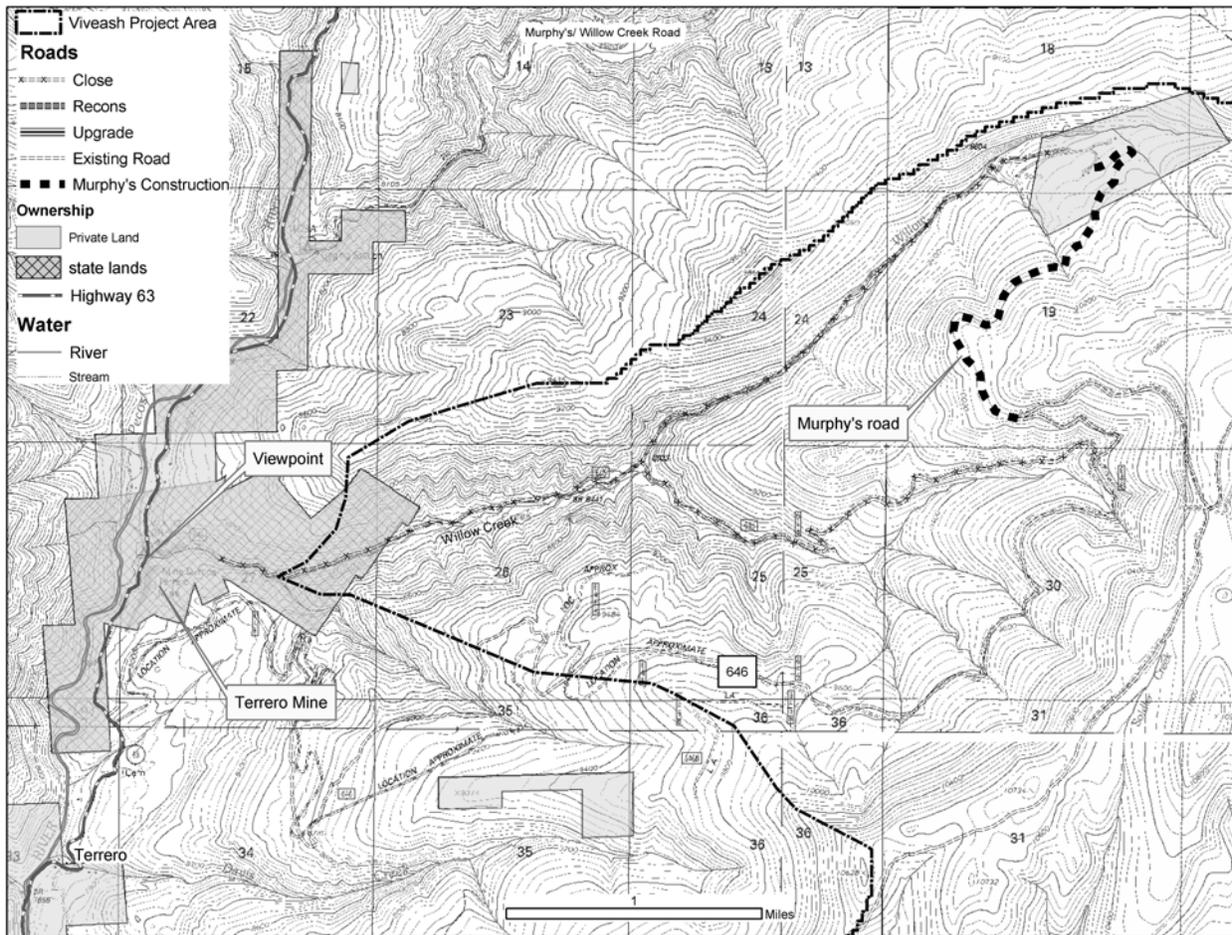
Figure 9: Murphy road

The proposed realignment is in the upper reaches of the Willow Creek watershed. There are no trails, roads, private homes or other sensitive developments in the area with the exception of the benefiting landowner. The new construction crosses approximately one mile of National Forest and approximately .25 mile of the affected owner's private land. Most of the existing and proposed road runs through aspen stands on the northwest side of a ridge with moderately sloping hillsides. The groundcover consists largely of organic matter and grasses, with some shrubs and wildflowers. A portion of FR 645E that is to be closed, parallels Willow Creek for about 4 miles.

This road would have a only a slight effect on the scenic qualities of the landscape, primarily because it is not readily visible to the public. The sensitive viewshed is the Pecos Canyon and the state highway. The Murphy road cannot be seen from the viewpoint of Willow Creek and State Road 63 (see figure 9). The view from this point is

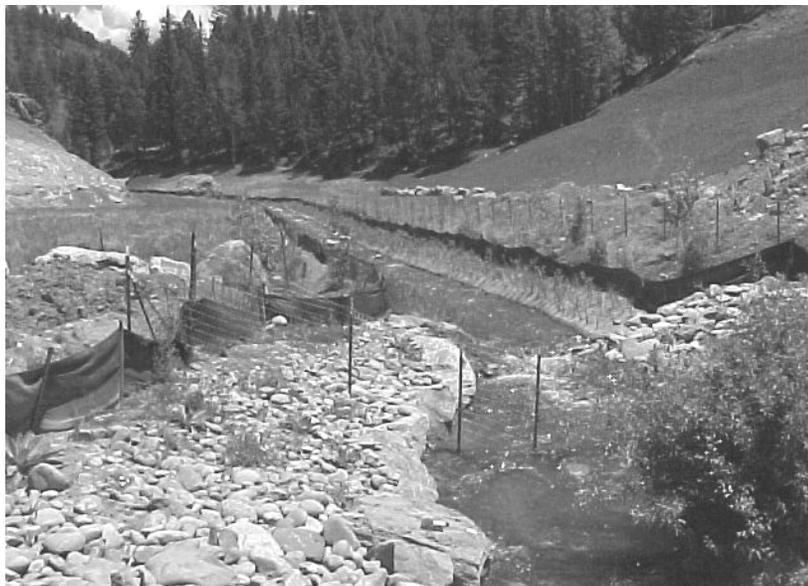
Figure 10: View of the Terrero mine remediation from Highway 63. The Murphy Road is not visible from this point.

bottom of Willow creek, Highway 63 is a sensitive viewpoint. The mine remediation efforts both past and ongoing dominate the foreground views. The Murphy road is not visible from this point and would not contribute to cumulative visual quality effects.
